Technical Service Bulletin

GROUP	NUMBER
CAMPAIGN	25-01-084G
DATE	MODEL(S)
NOVEMBER 2025	GV60 (JW1 EV)

SUBJECT: REAR TRANSVERSE TRIM INSPECTION & REPLACEMENT
(LIMITED COVERAGE CAMPAIGN L06G)

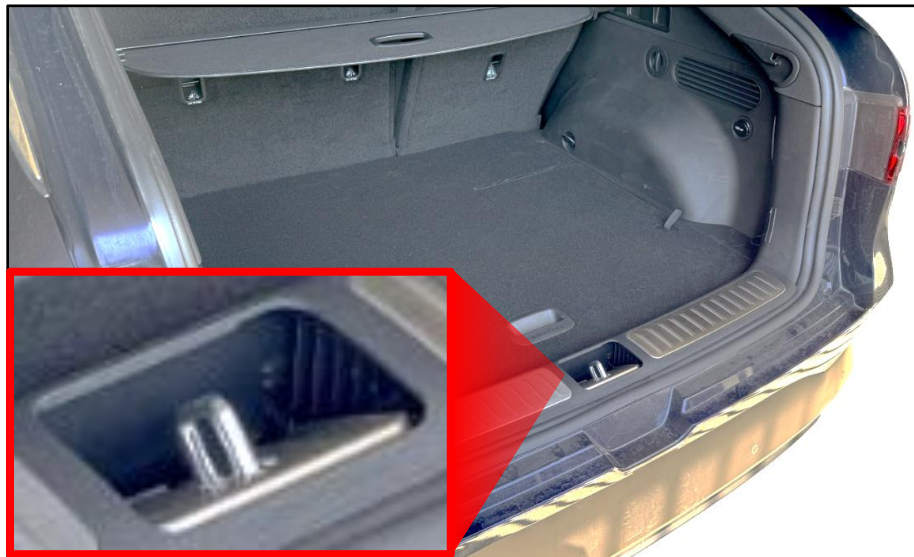
Description: Certain GV60 (JW1 EV) vehicles may have damaged stopper ribs on the transverse trim which may cause the spring-loaded striker cover to be stuck in a downward position. This bulletin provides instructions to inspect, and if necessary, replace the rear transverse trim.

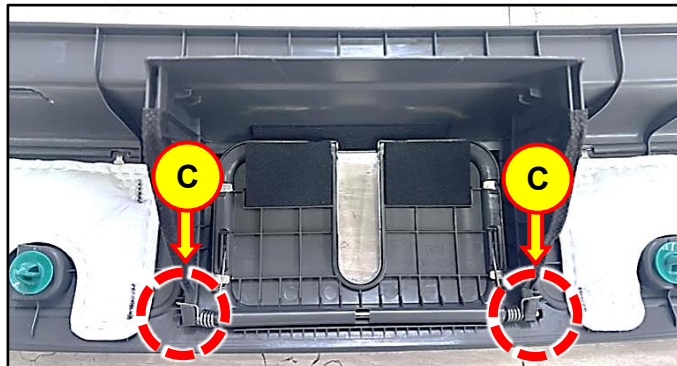
4. Visually inspect the stopper ribs (C) for damage:
- **NOT DAMAGED:** If **BOTH** stopper ribs are **NOT** damaged, complete **step 5** then proceed to **step 7**.
 - **DAMAGED:** If one or both stopper ribs are damaged, proceed to **step 5**.
