GENERAL MOTORS
DCS7379
URGENT - DISTRIBUTE IMMEDIATELY

Subject: N252528020 - Service Update
Upper Intermediate Steering Shaft Bolt Low Torque

Models: 2025 Cadillac Escalade ESV
2025-2026 Chevrolet Tahoe
2025 GMC Yukon

N252528020 Upper Intermediate Steering Shaft Bolt Low Torque

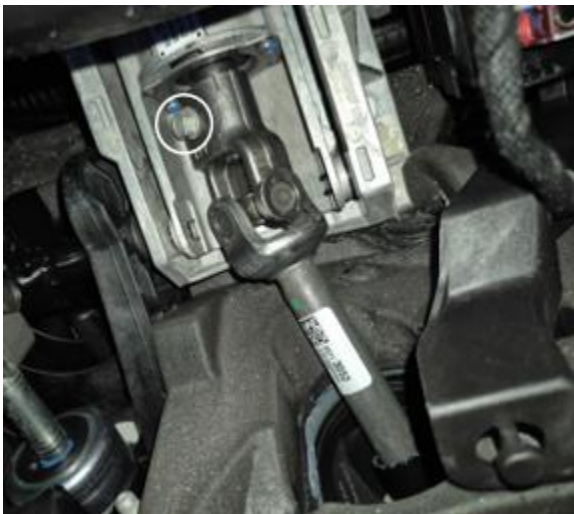
7022323

Condition	Certain vehicles listed above may have a condition in which the Upper Intermediate Steering Shaft Bolt is below torque specification.
Correction	Dealers will torque the Upper Intermediate Steering Shaft Bolt to specification.

1. Locate the steering column intermediate shaft bolt underneath the dash as shown.
2. Torque to 33 ft-lbs (45 N-m).
