INSTRUCTION TO SERVICE

ITS-61463		10/22/2025
SECTION:	460-Windows	
SUBJECT:	Passenger egress window striker pin failure during the window closure.	
ISSUE:	Passenger egress window striker pin failure due to welding error.	
CORRECTIVE ACTION:	Replace potentially faulty egressing window striker pins with certified parts.

ITS-61463

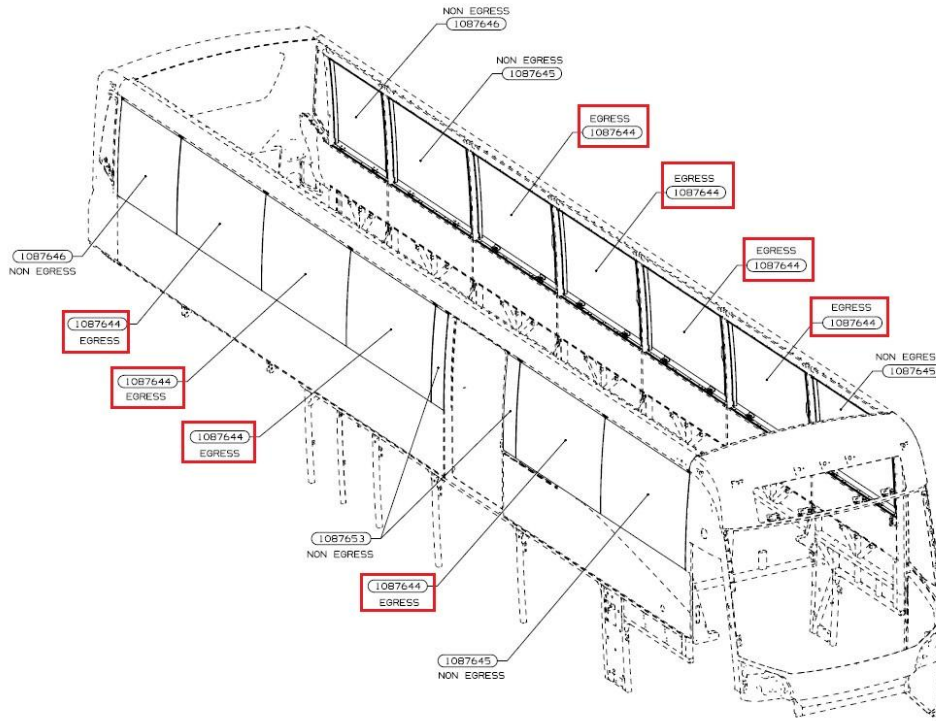
Window location reference.

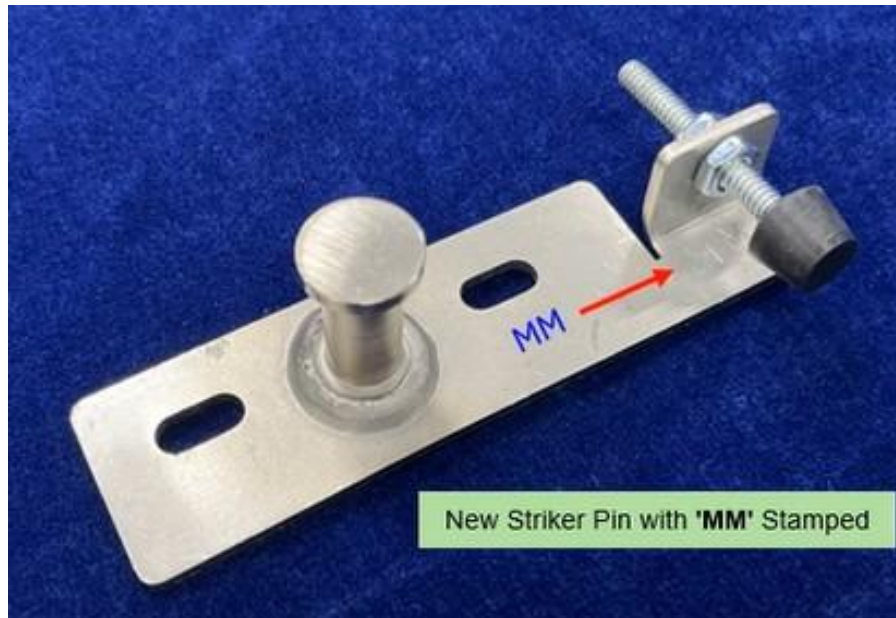
NOTE: If the existing striker pin assembly has “MM” stamped under the bumper, no need to replace. If the striker pin assembly do **NOT** have “MM” stamp under the bumper, proceed to the instructions below.

Striker pin assembly identification marks.
