Technical Information

CVPAM Surround View System Diagnosis B228600

DATE: OCTOBER 11, 2025

MODELS INVOLVED: M182 Grecale, M189 GranTurismo and M190 GranCabrio (All MY).

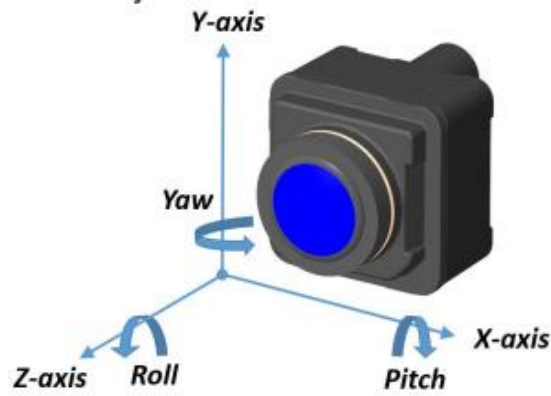
Tolerance Tables

Grecale	Nominal	Minimum	Maximum		GranTurismo & GranCabrio	Nominal	Minimum	Maximum
Front Roll Angle [°]	0	-5	5		Front Roll Angle [°]	0	-5	5
Front Pitch Angle [°]	16.31	11.31	21.31		Front Pitch Angle [°]	26.43	21.43	31.43
Front Yaw Angle [°]	0	-5	5		Front Yaw Angle [°]	0	-5	5
Left Roll Angle [°]	-171.59	-176.59	-166.59		Left Roll Angle [°]	0	-5	5
Left Pitch Angle [°]	48.2	43.2	53.2		Left Pitch Angle [°]	50	45	55
Left Yaw Angle [°]	91.2	86.2	96.2		Left Yaw Angle [°]	90	85	95
Right Roll Angle [°]	171.02	166.02	176.02		Right Roll Angle [°]	0	-5	5
Right Pitch Angle [°]	48.2	43.2	53.2		Right Pitch Angle [°]	50	45	55
Right Yaw Angle [°]	-102.54	-107.54	-97.54		Right Yaw Angle [°]	-90	-95	-85
Rear Roll Angle [°]	0.02	-4.98	5.02		Rear Roll Angle [°]	0	-5	5
Rear Pitch Angle [°]	39.18	34.18	44.18		Rear Pitch Angle [°]	44	39	49
Rear Yaw Angle [°]	+180 -180	179 178 177 176 175	-179 -178 -177 -176 -175		Rear Yaw Angle [°]	+180 -180	179 178 177 176 175	-179 -178 -177 -176 -175
