## STAR ONLINE PUBLICATION

**Case Number: S2521000004**

**Release Date: November 2025**

**Symptom/Vehicle Issue:** The customer is experiencing a "clicking" noise during turns while driving on WL vehicles

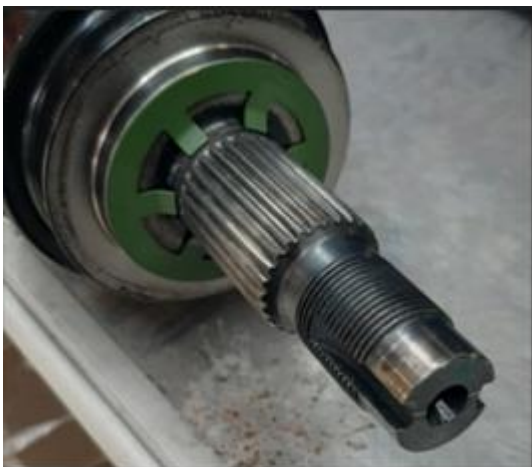
**Diagnosis:** Prior to any replacement of parts, please record the residual torque value of the halfshaft hub nut to see if it meets the Service Library specification. Please attach your initial torque reading on the vehicle work order

**Repair Procedure:** Please follow the service torque specs found under Service Library, Service Info/03 - Diff & Driveline/SHAFTS – Axle/Drive/Half - Front Halfshaft. If re-torquing the axleshaft hub nut does not resolve the concern. Then replace the halfshaft and confirm the green Xylan washer is present and not damaged
