GENERAL MOTORS
DCS7386
URGENT - DISTRIBUTE IMMEDIATELY

Subject: REVISION: N252521591-01– Service Update
Unwanted Integrated Brake Assist
Revised Warranty Information Table

N252521591 Unwanted Integrated Brake Assist

Revision: 01

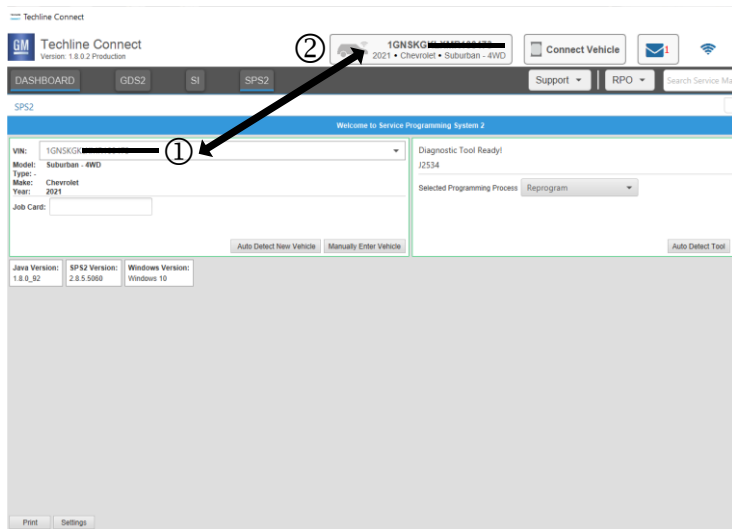
5743643

Caution: Be sure the VIN selected in the drop down menu (1) is the same as the vehicle connected (2) before beginning programming.

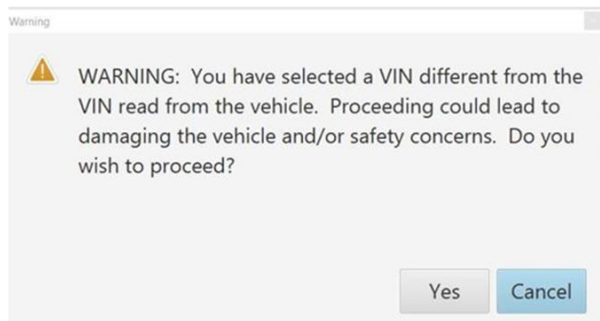
5877000

Important: If the vehicle VIN DOES NOT match, the message below will be shown.

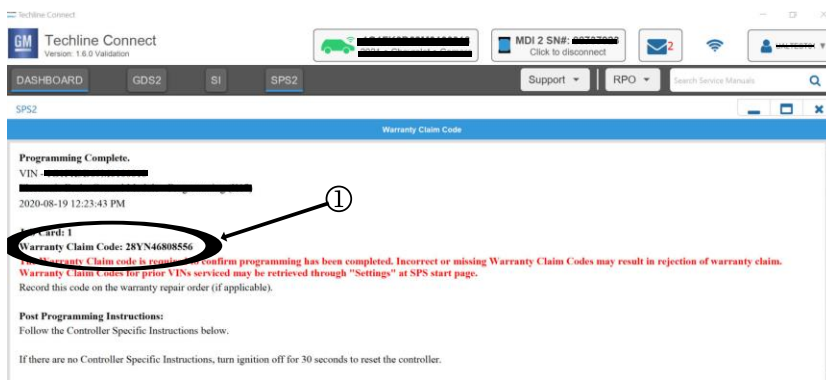
5644478

Note: The screenshot above is an example of module programming and may not be indicative of the specific module that is being programmed. Module selection and VIN information have been blacked out.

Important: To avoid warranty transaction rejections, you **MUST** record the warranty claim code provided on the Warranty Claim Code (WCC) screen shown above on the job card. Refer to callout 1 above for the location of the WCC on the screen.

1. Reprogram the Image Processing Module. Refer to *K124 Image Processing Module: Programming and Setup* in SI.

2. Record SPS Warranty Claim Code on job card for warranty transaction submission.
