**Technical Service Bulletin (TSB)**  
**Flash: Powertrain Control Module (PCM) Updates**

| REFERENCE: | TSB: 18-011-25 REV. C<br>GROUP: 18 - Vehicle Performance | Date: | November 18, 2025 | REVISION: | 18-011-25 REV. B |
| VEHICLES AFFECTED: | 2024 (JL) Jeep Wrangler<br>This bulletin applies to vehicles equipped with a 2.0L I4 DOHC DI Turbo Engine W/ESS (Sales Code EC1). | | | MARKET APPLICABILITY:<br><div><div><input checked="" type="checkbox"/> NA</div><div><input checked="" type="checkbox"/> SA</div><div><input checked="" type="checkbox"/> EE</div></div> <div><div><input checked="" type="checkbox"/> MEA</div><div><input checked="" type="checkbox"/> IAP</div><div><input checked="" type="checkbox"/> **CH**</div></div><br>NOTE: This bulletin applies to the Enlarged Europe, North America, South America, India & Asia Pacific, Middle East and Africa and China markets. | |

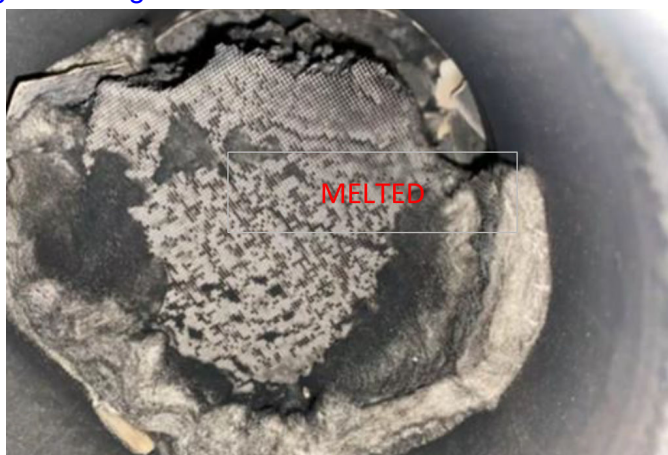
10. Remove the Upstream Oxygen Sensor and using a borescope, is the catalytic converter internally melted/ cracked or brain pattern [Fig. 3](#) and [Fig. 4](#) ?

**Fig. 3**  
Melted Catalyst

- YES >>> Replace the catalytic converter. Refer to the detailed service procedures listed in DealerCONNECT>Service Library>Service Info>under: 11 - Exhaust System / Converter, Catalytic / Removal and Installation. Use LOP (11-50-01-91). Proceed to [Step 11](#).
- NO >>> Use Inspect LOP (11-50-01-90). Proceed to [Step 11](#).
