STAR ONLINE PUBLICATION

Case Number: S2519000012

Symptom/Vehicle Issue: Diagnostic Trouble Codes C2217 And Or C1592. Service Electric Power Steering Message On Cluster.

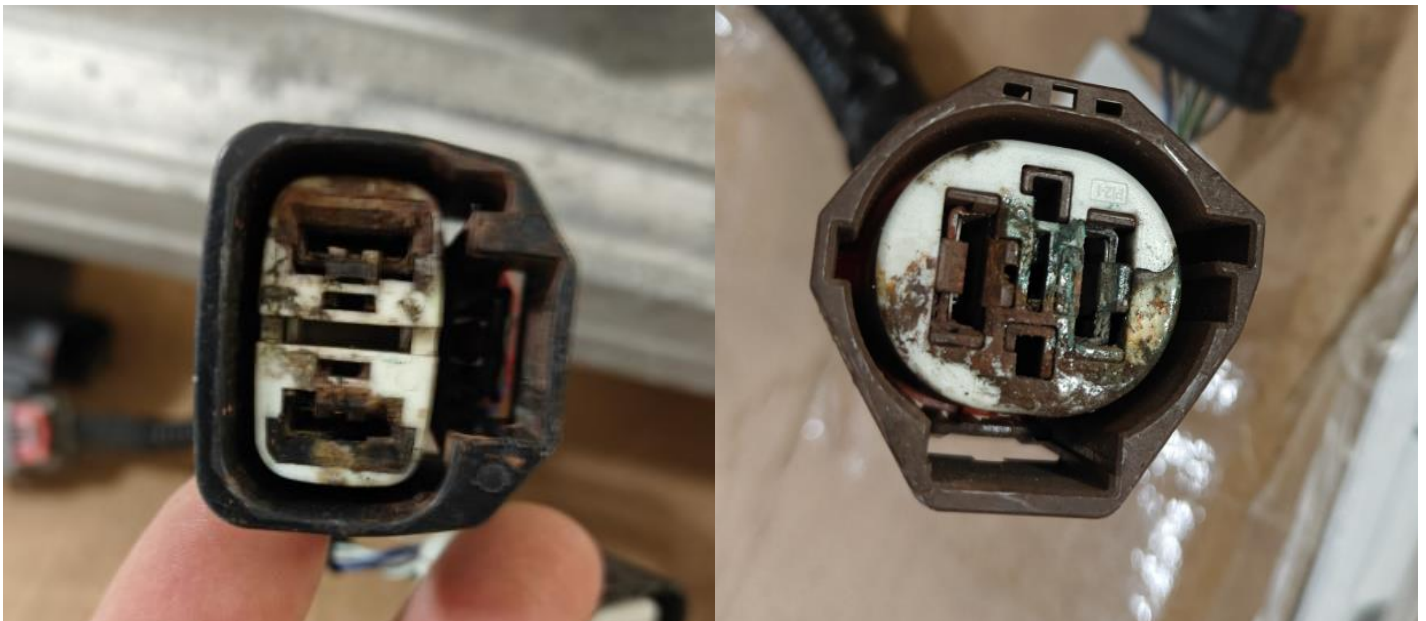
Discussion: When performing diagnostics and preliminary checks on the electric power steering (EPS), disconnect the large gauge C1 connector. Look for any signs of corrosion or water in the connector. If it does exist, inspect other connectors in the left side body harness for presence of water. Replace the EPS and if necessary, the left side body harness and the EPS jumper harness.
