Service Bulletin

Bulletin No.: PIC6616A

Subject: Squeak Noise from Rear of Vehicle

Brand:	Model:	Model Year:		VIN:		Engine:	Transmission:
		from	to	from	to		
Cadillac	OPTIQ	2025 - 2026		All	All	All	All

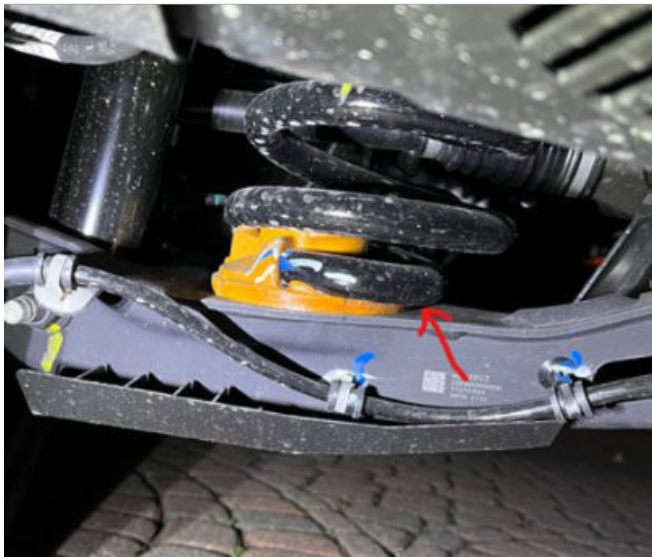
6991335

Involved Region or Country	North America
Condition	Customers may comment on a squeak noise coming from the rear of the vehicle when going over bumps.
Cause	Possible rear coil spring not seated properly on the rear spring isolator.

Images below show rear spring not properly seated on isolator.

If the technician finds the rear spring not properly installed, they will need to follow the repair instructions as outline in Service Information to properly install spring.

Note: inspect the spring isolator for damage and replace as needed.

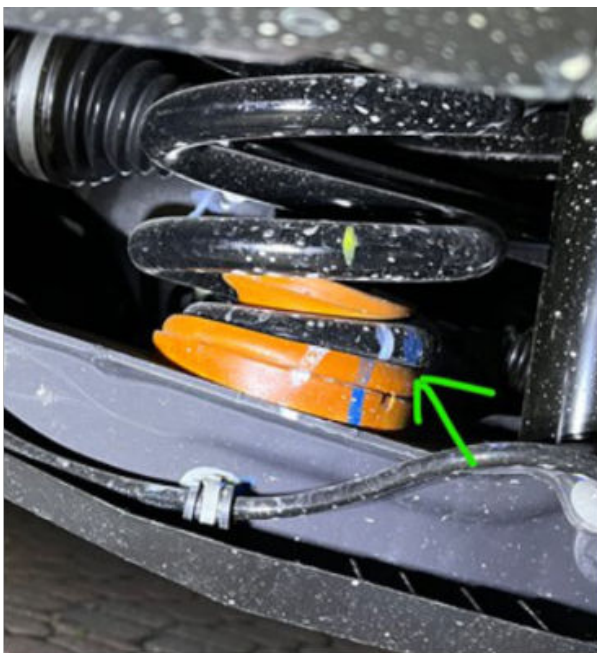
6991336

The following images show the rear spring properly mounted on the isolator.
