GROUP	MODEL
ENG	2021-2024MY K5 (DL3a) w/Theta III 2.5L T-GDI
NUMBER	DATE
260	November 2025

## TECHNICAL SERVICE BULLETIN

### ITM REPLACEMENT AND ECM LOGIC IMPROVEMENT (CA2511)

This bulletin provides information to replace the Integrated Thermal Management Module (ITM) and then upgrade the Engine Control Module 'ECM' system software on certain K5 (DL3a) vehicles, in the event the Multifunction Indicator Lamp (MIL) is illuminated with DTC(s) P218100, P2181F0, and/or P2181F1 stored. This condition may occur due to degradation of the diaphragm inside the ITM. There are no drivability or other symptoms associated with this condition. Follow the procedure outlined in this publication to replace the ITM and upgrade the ECM software in 'Manual Mode' only. Refer to [SST081](#) for software upgrade instructions using Kia Diagnostic System (KDS) tablet and VCI-II and confirm the Upgrade Event Number/Name, ROM ID Information, and Manual Mode passwords on the applicable vehicle.

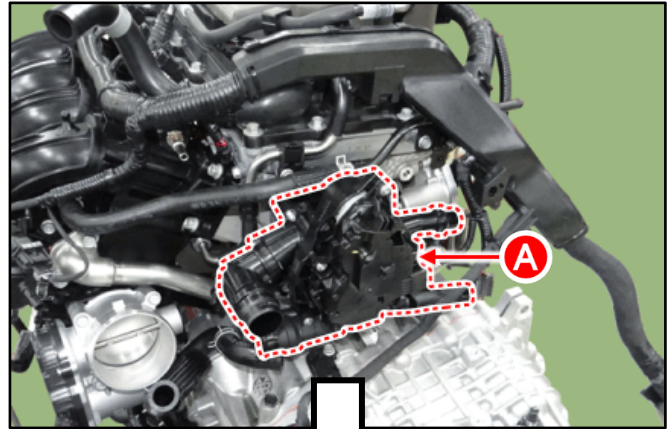
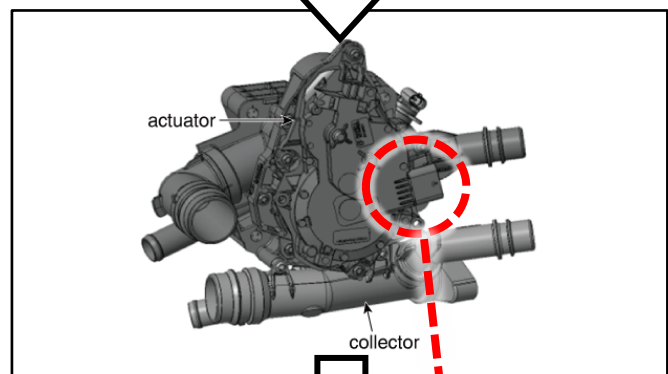
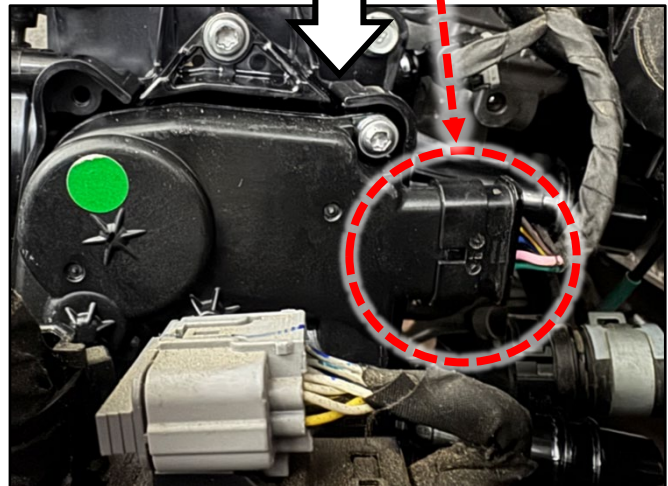
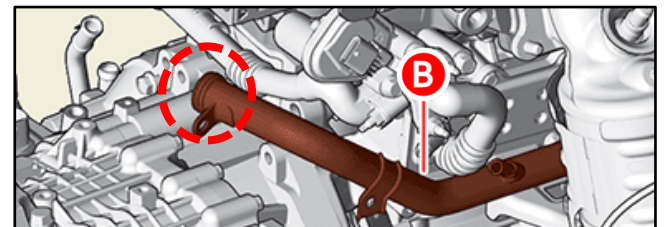
**Note:** The **ITM connection orientation** changes after replacing the new ITM part. The locking tab will face the engine.

Trying to make the connection on the new ITM in the same orientation as the original ITM may damage the connector pins/terminals.

1. Replace the Integrated Thermal Management Module 'ITM' (A) by referring to "Engine Mechanical System → Cooling System → Integrated Thermal Management Module (ITM) → Repair procedures" in the applicable Shop Manual on KGIS.

Tightening torque for bolts:  
7.2 - 8.7 lb.ft (9.8 - 11.8 N.m)

**DO NOT** disassemble the **actuator** and **collector**. The new ITM is supplied as an assembly unit.

2. Reinstall all removed parts in reverse order of removal.

3. Install a new inlet pipe (B) O-ring on the **red circled** area shown.
4. Proceed to upgrade the 'ECM' with Event 850 software in **Manual Mode** only, **after** ITM part replacement is completed by referring to the ROM ID table on page 4.
5. Verify normal vehicle operation.
