GROUP	MODEL
ENG	2023MY Sportage (NQ5, NQ5a) w/Theta III 2.5L GDI
NUMBER	DATE
259 (Rev 1, 11/6/2025)	October 2025

## TECHNICAL SERVICE BULLETIN

### ITM REPLACEMENT AND ECM

### LOGIC IMPROVEMENT (CA2509)

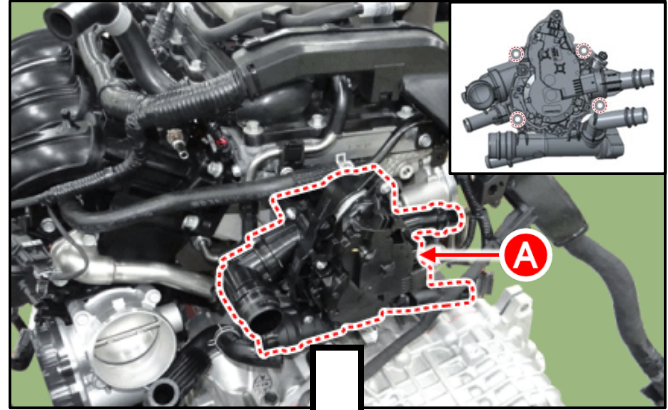
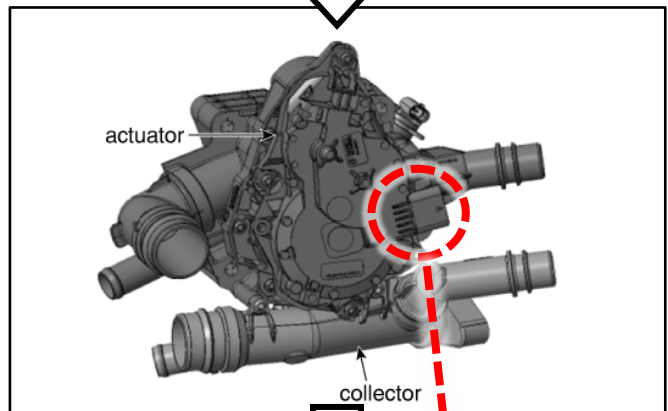
This bulletin provides information to replace the Integrated Thermal Management Module (ITM) and then upgrade the Engine Control Module 'ECM' system software on certain vehicles, in the event the Multifunction Indicator Lamp (MIL) is illuminated with DTC(s) P218100, P2181F0, and/or P2181F1 stored. This condition may occur due to degradation of the diaphragm inside the ITM. There are no drivability or other symptoms associated with this condition. Follow the procedure outlined in this publication to replace the ITM and upgrade the ECM software in 'Manual Mode' only. Refer to [SST081](#) for software upgrade instructions using Kia Diagnostic System (KDS) tablet and VCI-II and confirm the Upgrade Event Number/Name, ROM ID Information, and Manual Mode passwords on the applicable vehicle.

1. Replace the Integrated Thermal Management Module 'ITM' (A) by referring to "Engine Mechanical System → Cooling System → Integrated Thermal Management Module (ITM) → Repair procedures" in the applicable Shop Manual on KGIS.

Tightening torque for bolts:  
7.2 - 8.7 lb.ft (9.8 - 11.8 N.m)

**Do NOT** disassemble the [actuator](#) and [collector](#). The new ITM is supplied as an assembly unit.

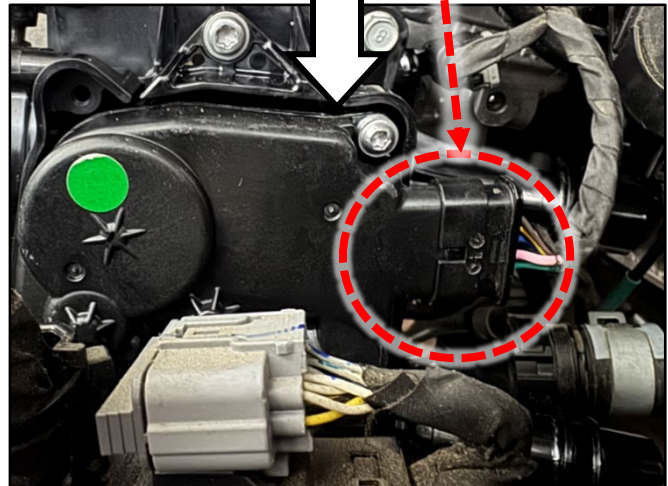
**Note:** The ITM connection orientation changes after replacing the new ITM part. The locking tab will face the engine.

Trying to make the connection on the new ITM in the same orientation as the original ITM may damage the connector pins/terminals.

2. Reinstall all removed parts in reverse order of removal.
