GROUP	MODEL
BOD	2026MY K5 (DL3)
NUMBER	DATE
346	November 2025

TECHNICAL SERVICE BULLETIN

SERVICE ACTION: REAR SEAT CARPET FLOORMAT INSPECTION AND REPLACEMENT (SA628)

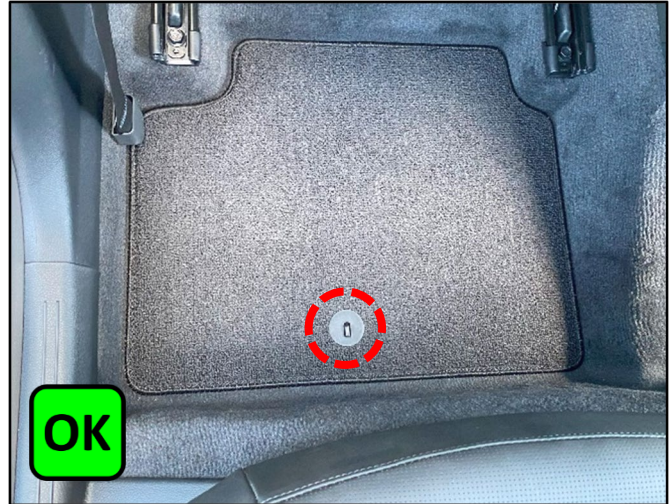
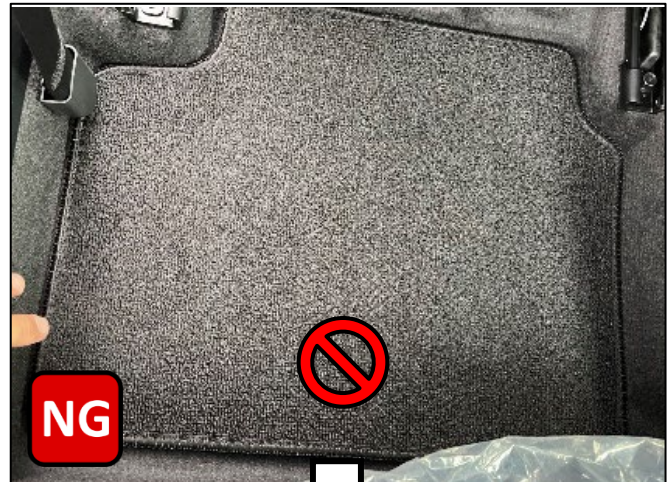
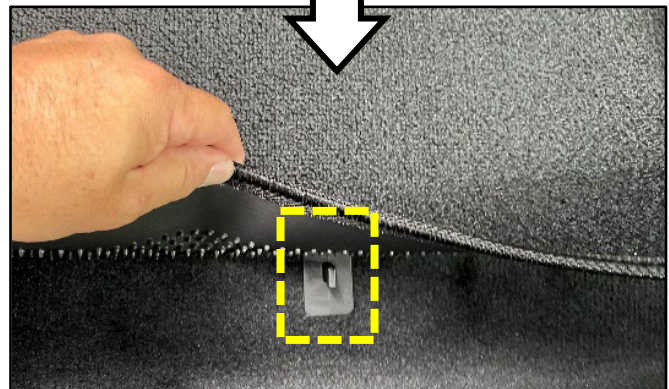
1. Inspect the rear passenger carpet floormats, for missing grommets.

Note: **Both left and right side.** The VIN records will have PIO Code "CF" to indicate PIO Floormats.

- If the floormat has the grommet and is secured to the floor carpet hook (**OK**), no further action is needed.
- If the floormat does not have the grommet and the floor carpet has a hook (**NG**), then replace the rear carpet floormats with a new set that includes the attachment positioning grommet to close this action.

Note: Check under the floormat as the rear floor carpet should have an attachment hook.

PN: L3F14 AU200 (Rear Floormats)
