## SERVICE BULLETIN

**APPLICABILITY:** 23-25MY Outback/Legacy Models (including Wilderness models)  
 23-25MY Ascent Models  
 24-26MY Impreza  
 24-26MY Crosstrek (including Wilderness models)  
 24-25MY WRX  
 25-26MY Forester  
 26MY Forester Wilderness

**NUMBER:** 15-305-22R  
**DATE:** 11/15/22  
**REVISED:** 11/14/25

**SUBJECT:** Reprogramming File Availability for Optimization of Gen 4.5 Denso CP1.5 Infotainment Systems

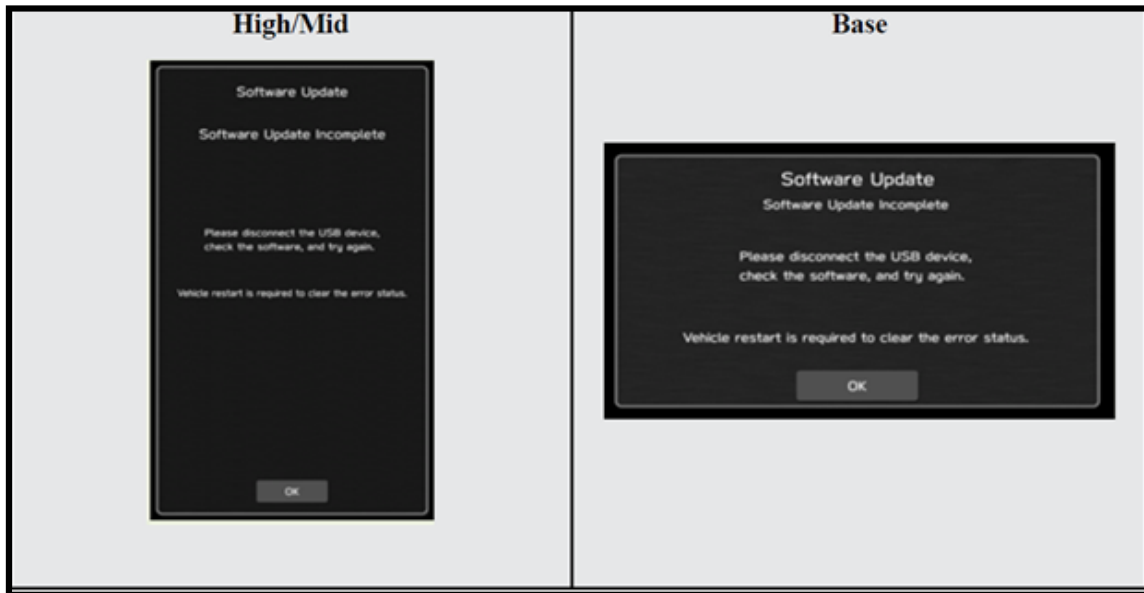
If you get the message **Software Update Incomplete** as shown below, please don't replace the hardware but retry updating the software according to the instructions in [Appendix 6 \(page 30\)](#).

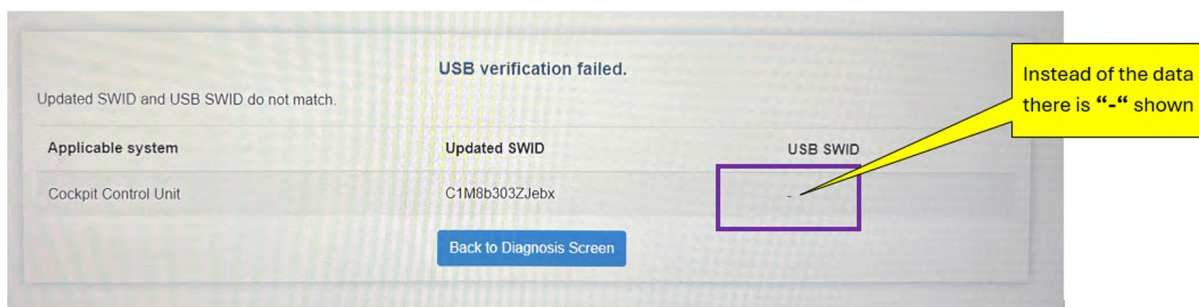
**IMPORTANT NOTE:** In rare cases when the CCU does not complete the USB authentication check in time resulting in the message box below.

The recovery steps are outlined below.

- Perform a soft reset of the CP1 by holding down the CID volume knob. Please leave USB Drive connected.
- Once the CP1 has restarted, retry step ii on the previous page and then press the “Start Reprogramming” button. Please wait for 2 minutes after CP1 has restarted, before press the “Start Reprogramming” button.
- If the same failure is encountered again, please proceed with the diagnostic of failure by checking the USB drive data integrity.

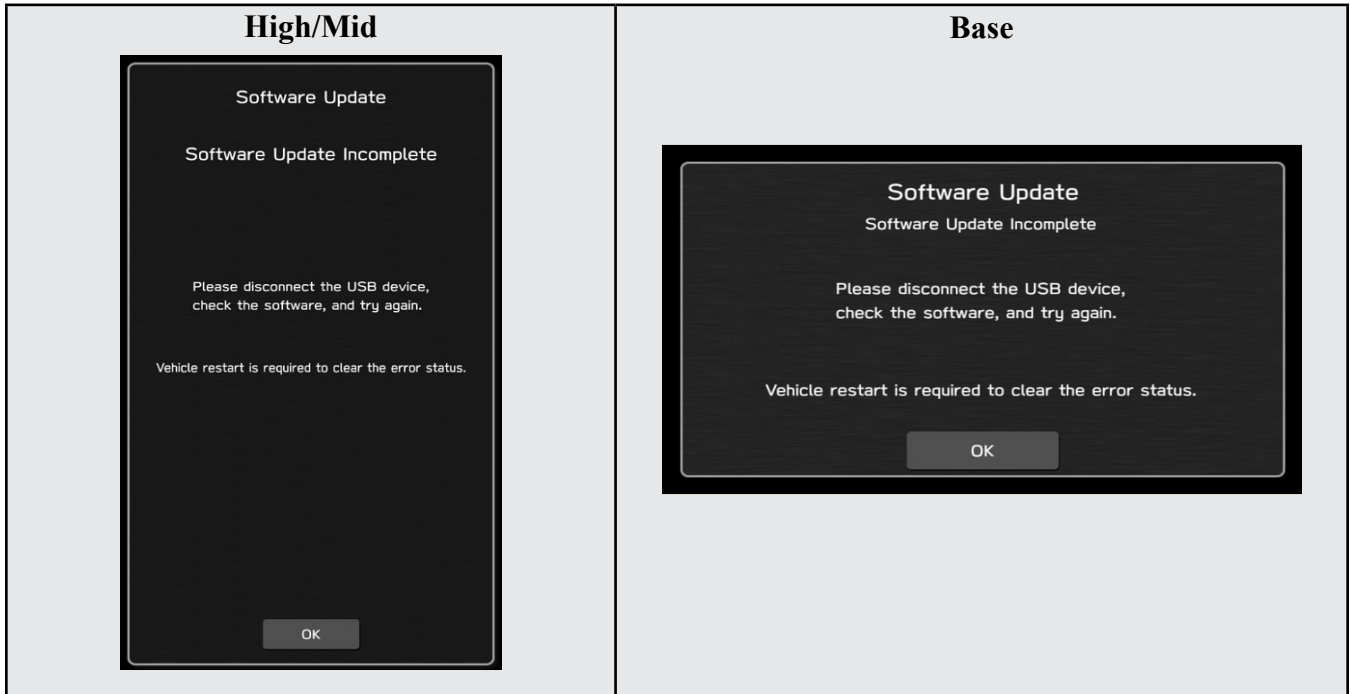
### 1-1. Select OK in the screen below

- If the first attempt of update fails with the message below, follow the steps described below 1-2 to 1-8 before retrying the software update.

### 1-2. Turn the ignition switch or the engine OFF, and turn it ON again.
