SERVICE BULLETIN

APPLICABILITY: 2019-23MY Crosstrek PHEV

NUMBER: 09-137-25

SUBJECT: Crosstrek Hybrid Front Exhaust Pipe Extension

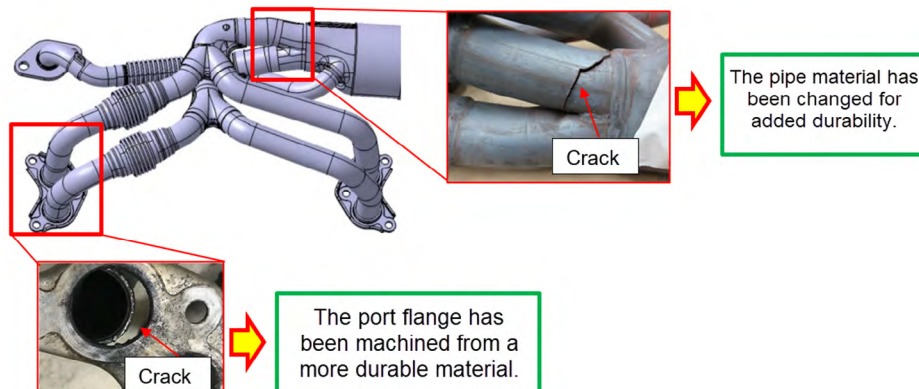
DESCRIPTION OF DESIGN CHANGE:

In the interest of customer satisfaction, Subaru of America, Inc. (SOA) is extending the Federal Emissions Extended Defect Warranty for the Front Exhaust Pipe (EPF) on 2019-23 model year Crosstrek Plug-in Hybrid vehicles from 8 years or 80,000 miles to 15 years or 150,000 miles (whichever comes first). Over time, applicable models may experience fatigue fractures or cracking in the front exhaust pipe at the exhaust manifold junction. Customers may report an odor or a fluttering noise caused by an exhaust leak. If it is determined that the odor or noise is caused by a cracked front exhaust pipe, the part will be covered under this warranty extension.
