## SERVICE BULLETIN

**APPLICABILITY:** 2024MY Crosstrek & Impreza **NUMBER:** 09-118-24R

**SUBJECT:** DTCs P2404 & P0087 / Reprogramming Files **DATE:** 04/05/24

**REVISED:** 11/20/25

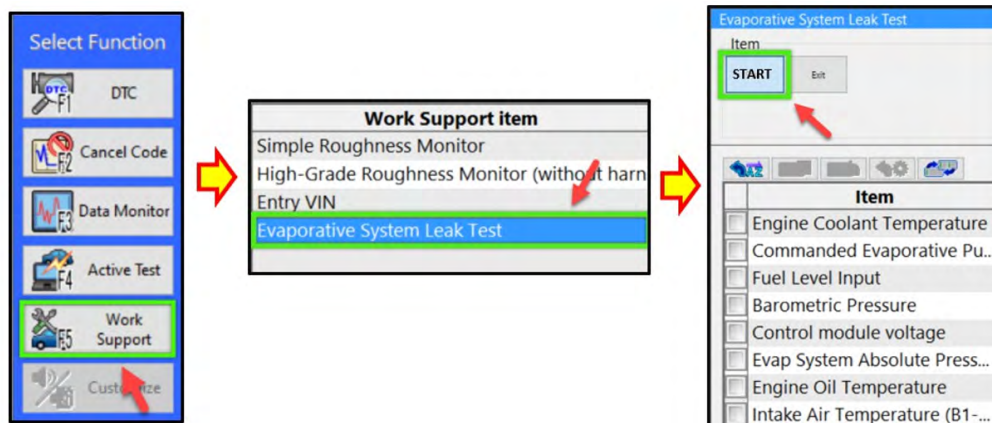
Once the evaporative system leak test is complete, check the DTCs and examine the vacuum value results. Record the value shown in the row labeled MID: \$3C, TID: \$C4, and Scaling ID: \$FE. This value should be lower than -0.26 PSI.

Value Must Be Lower Than -0.26 PSI

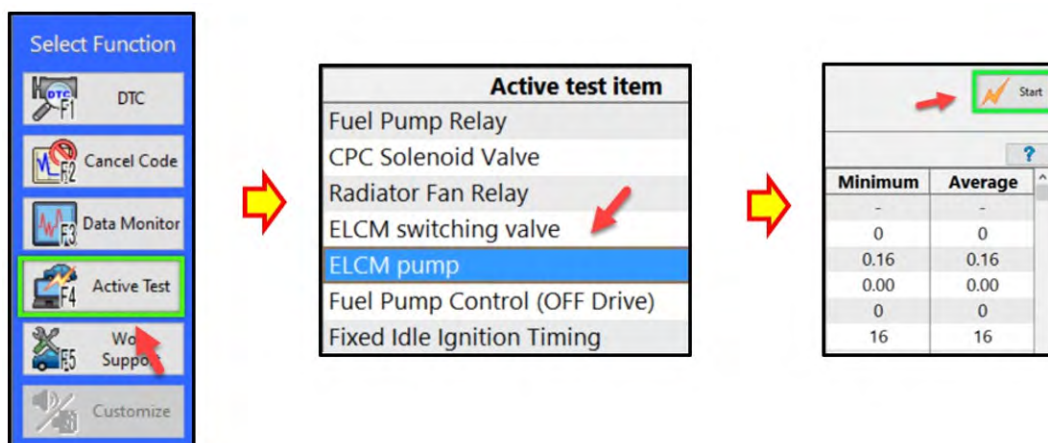
Once the ELCM Pump Active Test has been performed for a period of 35 minutes or more, repeat the Evaporative System Leak Test outlined in STEP 6. Check the DTCs and the vacuum value results.
