## Dinette Right-Seat Brace Bolt Torque

Rapid Response Quality Alert 26-01

WGO Model Year	Revision	Make	Model	Model Code(s) (Floorplan)	WGO Built/ Manufacturing Dates
2026	2	Winnebago	Revel	B44	7/28/2025 – 9/22/2025

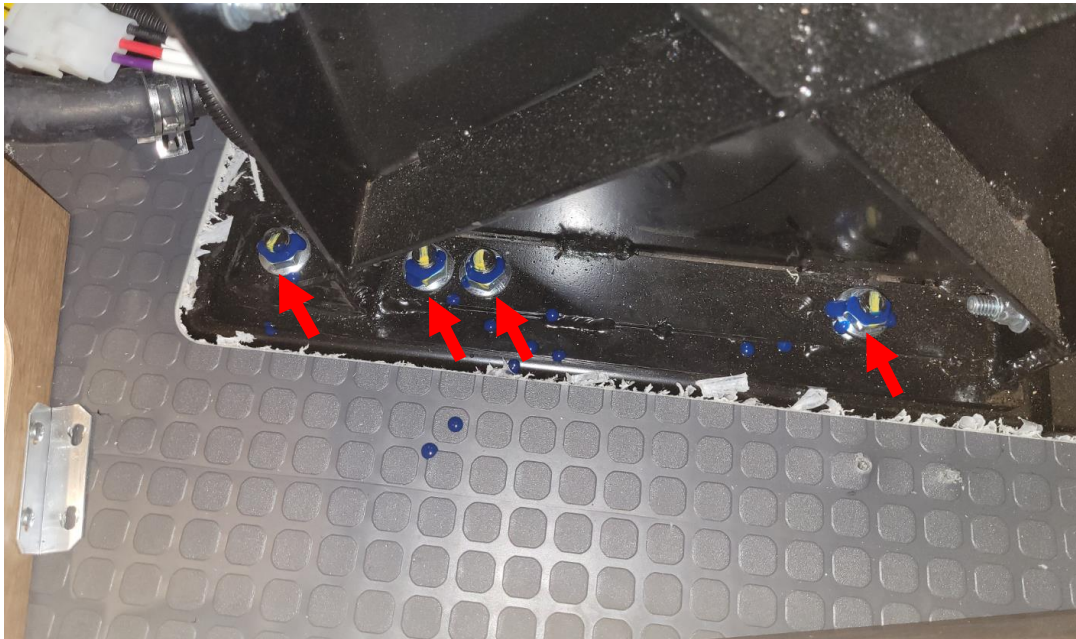
Figure 12:  
Bolts needing to be torqued and have Loctite added.

We have identified a potential quality issue related to some Revel B44E units, specifically regarding the securing of the dinette right-seat brace to the floor. The required torque specification of 76.6 Nm  $\pm$  7.7 Nm may not have been achieved during assembly, and torque verification marks may not have been applied. Our records indicate that units impacted by this potential issue are at your dealership.

1. Check all four bolts with the torque wrench and if not at the spec tighten with the 76.6 NM torque wrench until it clicks. Torque mark the bolt after. If it already had a torque mark on it, then use a different color marker than what was on it.
2. With Loctite 243 add the Loctite to the top of the nut at least halfway around. This allows the Loctite to seep from the top of the nut into the threads.
3. Clean up any mess on the floor with a tissue before moving the cabinetry back in place.

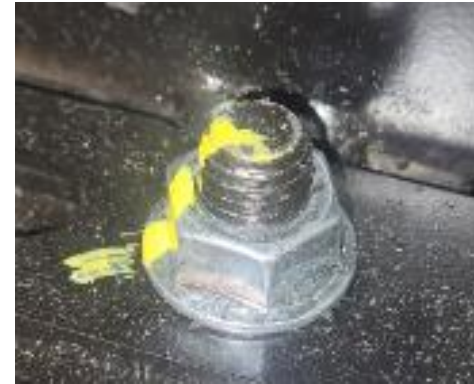
Figure 13:  
How a torque mark must be applied.

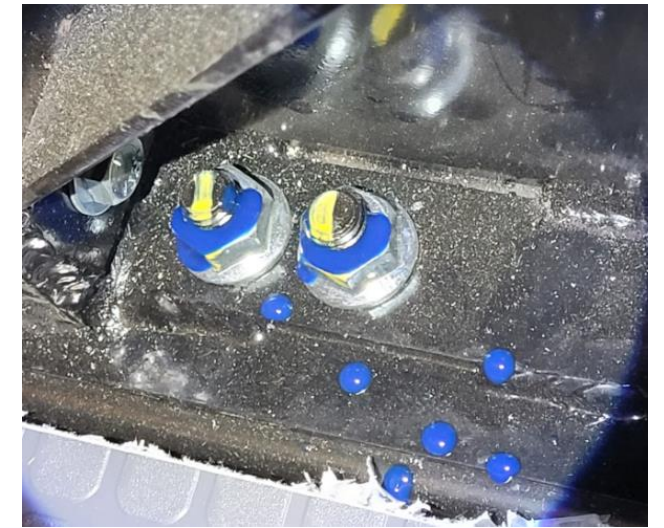
Figure 14:  
Correct Loctite coverage is on top of the nut at least halfway around.

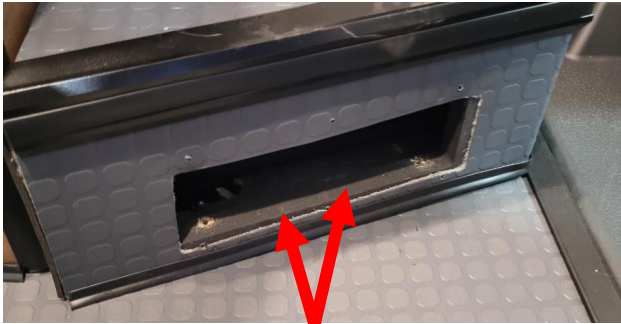
Ensure there is NO gapping here.

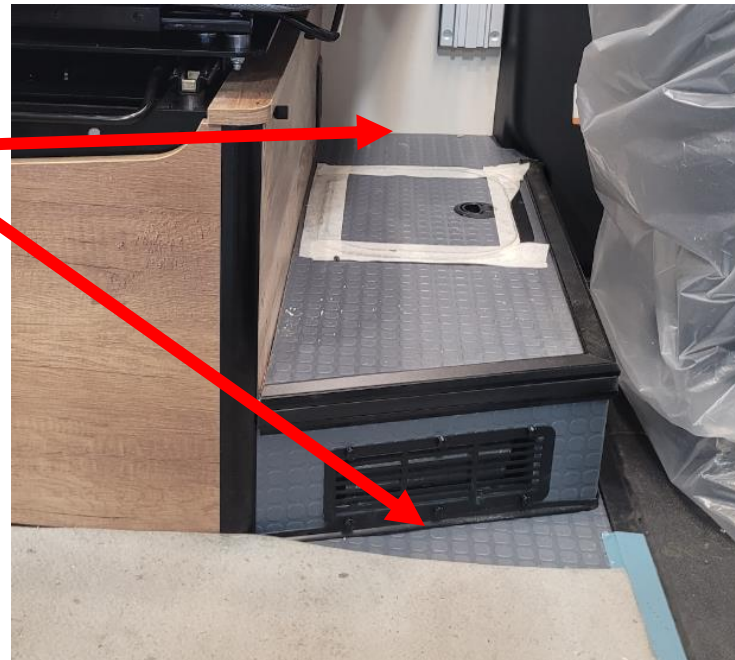
Figure 15: Riser

If you are unable to get riser to sit against the floor, try using the same type of screws **here**, where there is not already a hole present. Be careful not to split the wood.

The riser will be tight in that area. You will need to push it as far in as you can and use a rubber mallet to get it all the way in.

When fastening down to the floor have someone stand on the riser or sit on it to weigh it down.
