TECHNICAL SERVICE BULLETIN

Tailgate Paint Wear

25-2551

| Ford 2021-2025 Bronco |

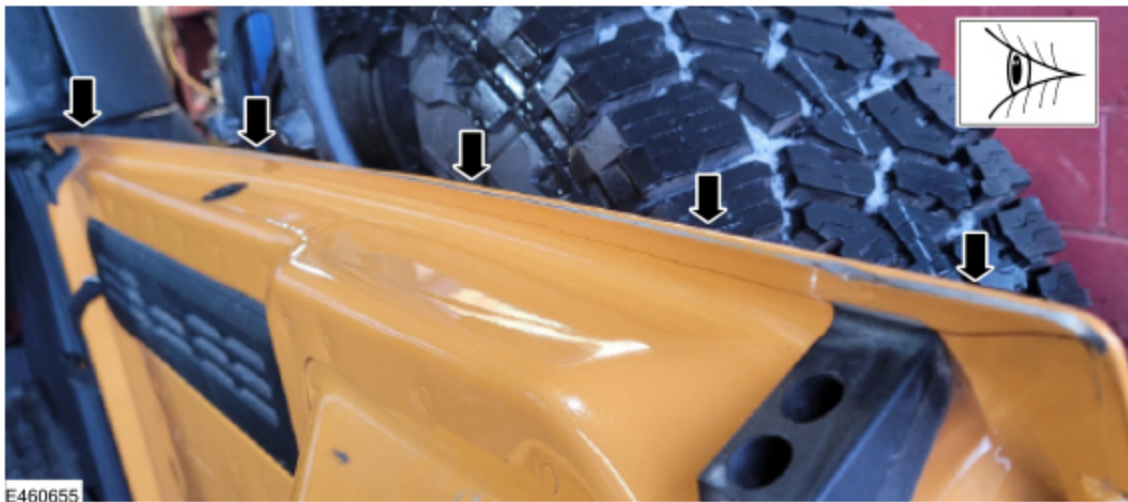
Figure 1

Issue: Some of the vehicles listed in the model statement above may exhibit paint wearing along on the top inner edge of the tailgate where the rear window weather strip contacts the tailgate. This may be due to the accumulation of dirt between the rear window seal and tailgate.

1. Does the top inside edge of the tailgate where the rear window weather strip contacts the tailgate show paint wear similar to Figure 1?

- (1). Yes - proceed to Step 2.
 - (2). No - this article does not apply.
2. Refinish the tailgate as required using a Ford approved refinish system. Repair outside of this article.
 3. Remove the spare tire and spare wheel mounting bracket. Refer to [WSM](#), Section 501-03 Removal and Installation > Spare Wheel Mounting Bracket.
 4. Clean the outside and inside edge of the tailgate to remove any dirt and debris.
 5. Measure 10 mm (0.39 inches) from the top edge of the tailgate and apply a piece of painter's tape down the entire length of the tailgate. This will help with aligning the mylar protective film. (Figures 2-3)
