TECHNICAL SERVICE BULLETIN

Illuminated MIL With DTCs P0301-P0306, P0201-P0206 And/Or Various Other DTCs Stored In The PCM

25-2569

| Ford 2021-2025 F-150 | Engine: 3.5L PowerBoost Built on or before 14-Apr-2025 |

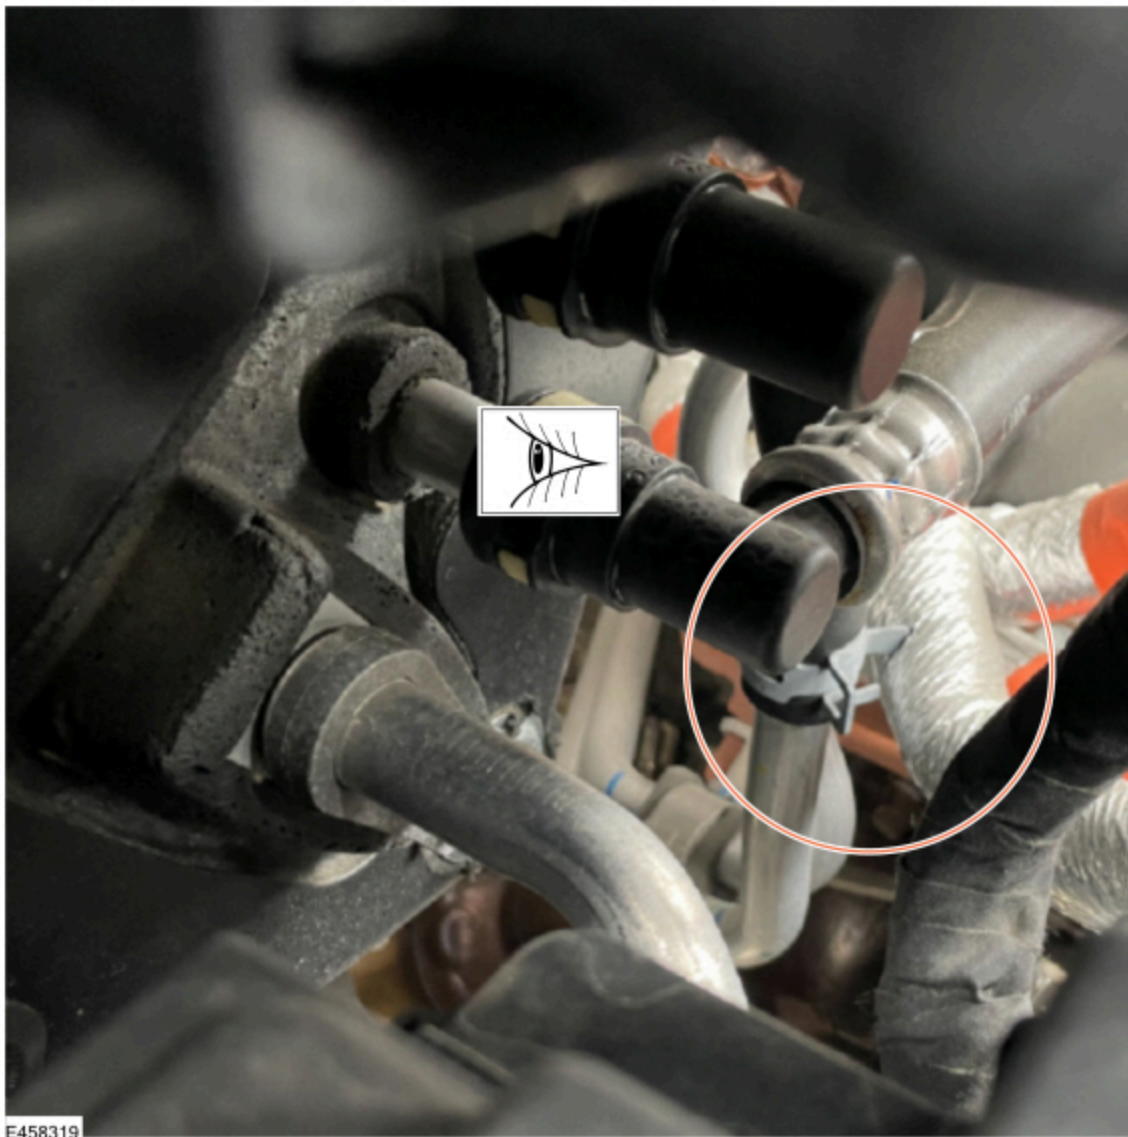
Figure 1

Issue: Some of the vehicles listed in the Model statement above may exhibit an illuminated MIL with DTCs P0301-P0306, P0201-P0206 and/or various other powertrain DTCs stored in the PCM. This may be due to the engine harness contacting the hose crimp end or spring clamp tangs on the exhaust heat exchanger heater hose assembly.

4. Locate the exhaust heat exchanger heater hose assembly spring clamp under the hood near the rear of the engine beneath the PCM. Refer to the WSM, Section 303-03C > Description and Operation > Component Location and Figure 1. Observe the orientation of the spring clamp. Are the heater hose clamp tangs pointed toward and/or contacting the 12A581B engine harness? (Figure 1)

(1). Yes - rotate the hose clamp 180 degrees so that the tangs are orientated away from the harness. (Figure 2)
Proceed to Step 5.
