**SIB 65 27 24**

**KNEE AIR BAG CCM G05 VARIANT WIRE HARNESS REPAIR**

2025-11-25

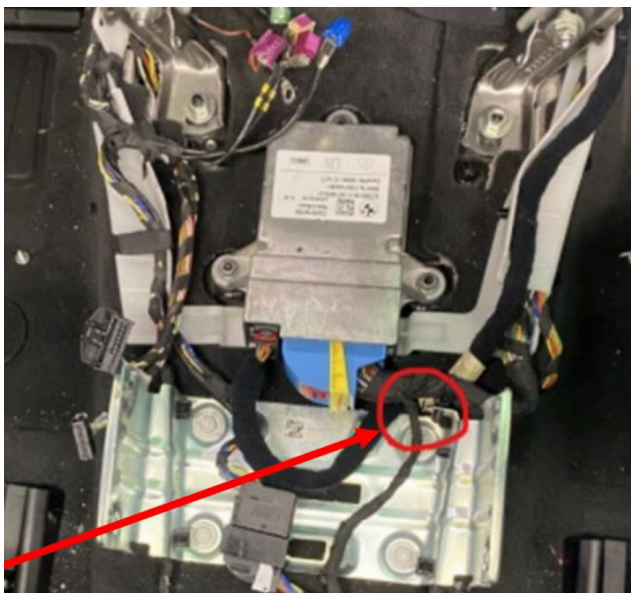
Over time, the wiring harness going to the knee air bag(s) can rub against the metal support tubes for the instrument panel, chafing and damaging the wiring.

6. Cover the edge of the center console support (the edge inside the circle) with felt tape (part number **54 34 7 248 700**).
