| <b>Voluntary Service Campaign</b> | <b>2025MY EV6 (CV1a)</b> |
| <b>SC343 (Rev 1, 11/18/2025)</b> | <b>June 2025</b> |

### PDC LOGIC IMPROVEMENT AND PRA REPLACEMENT FOR DTC P1B7700 (SC343)

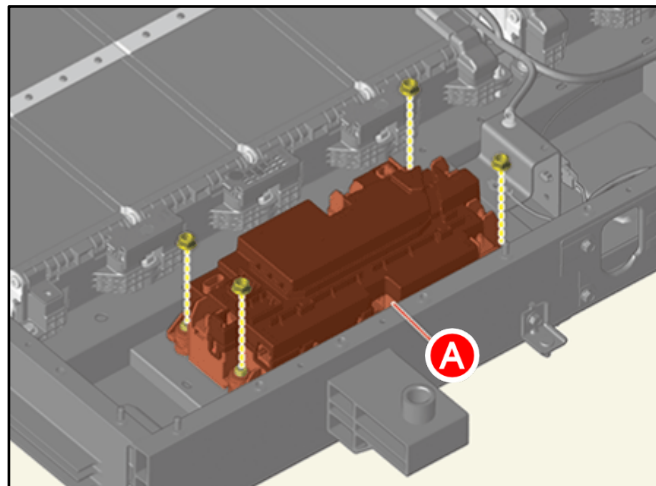
**NOTE:** The six (6) PRA Bus Bar (B) retaining bolts are not reusable. All bolts (x6) MUST be replaced with new parts.

Tightening torque for nut/bolt (X):  
5.8 - 8.7 lb.ft (7.8 - 11.8 N.m)

1. Replace the power relay assembly (PRA) (A) by referring to “Battery Control System → High Voltage Battery Control System → Power Relay Assembly → Removal and Installation” in the applicable Shop Manual on KGIS.
