Fixing Unintended Wiper Sweep

TSB-82-003-WST

Engine or Vehicle Affected:

- ▶ 57X
- ▶ 49X
- ▶ 47X

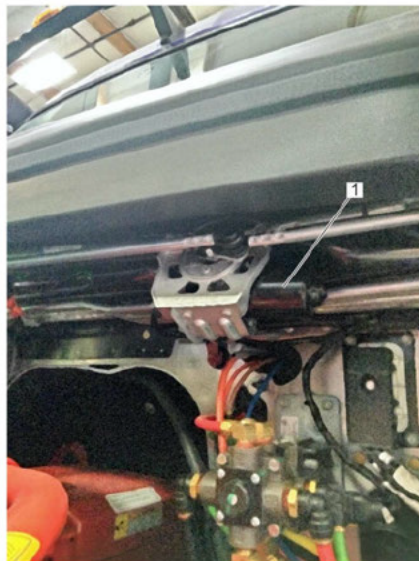
Fig. 1, Wiper Motor

Some Western Star vehicles built prior to January 1, 2023, may have a wiper motor that receives power before the ASAM, the wiper sweeps once at key-on. This may result in a random unintended wiper swipe. ASAM controllers built after January 1, 2023 (ASAM2021), received new hardware and software that corrected for the unintended wipe. The ASAM21 controllers are not backward compatible and cannot be installed on vehicles built prior to 2023. Replacing the wiper motor will resolve the issue. See Fig. 1. Follow the procedure below to replace the wiper motor.

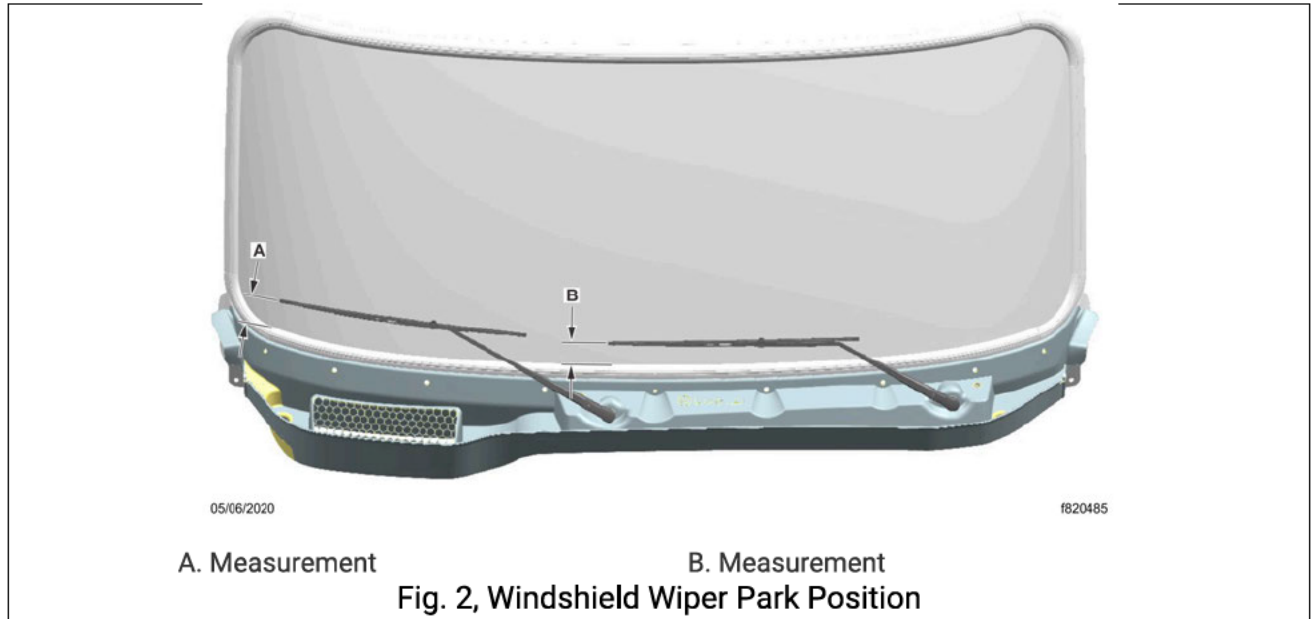
- Park the vehicle on a level surface, shut down the engine, and apply the parking brakes. Chock the tires.
- Open the hood.
- Check that the wiper blades are parked. If necessary, park them by turning the wipers on and then off. In the parked position, the blade tips should be aligned with the nominal park position markings, or the end of the right-hand wiper blade should be 2-3/4 in (70 mm) \pm 3/8 in (10 mm) above the bottom edge of the windshield, and the end of the lefthand wiper blade should be 2-1/16 in (53 mm) \pm 3/8 in (10 mm) above the bottom edge of the windshield. See Fig. 2.
