# ECP (Electronic Control Pneumatic) Modules, possible water ingress

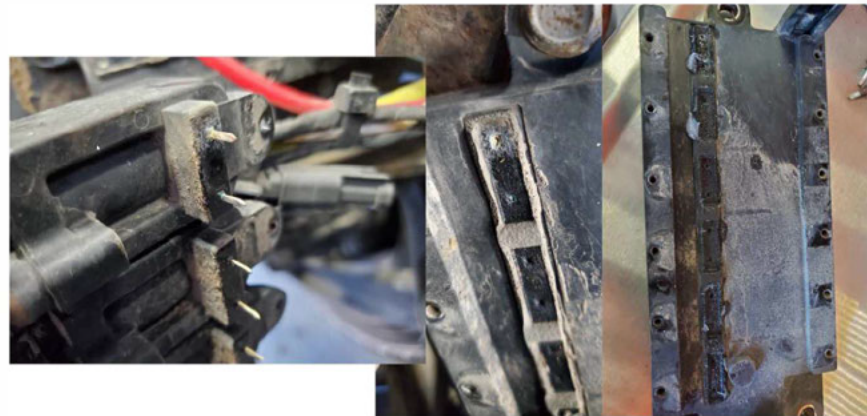
- Affected models: Freightliner M2+ and Western Star 47X, 49X
- ECP devices can experience water/contaminant ingress into the core tube of the solenoids through the exhaust port

- New O-ring piston solenoid assembly was released for service and production

- Fix as fail
