TECHNICAL SERVICE BULLETIN

Gear Shift Module (GSM) Concerns

25-2579

Ford 2021-2025 F-150	Built on or before 08-Sep-2025 Console shift
--------------------------------	---

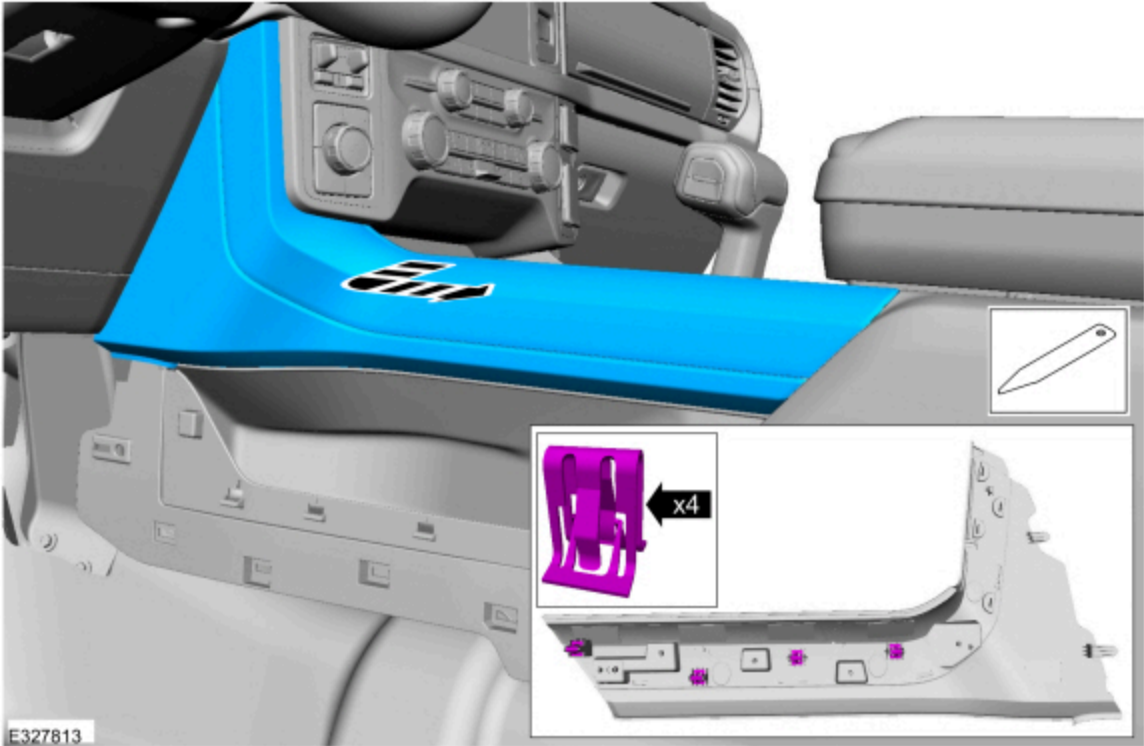
Figure 1

- With the system in Ready to Drive mode/engine running, apply and release the brake pedal while observing BRK_PDL_SW2_PID in the BCM. Does the BRK_PDL_SW2_PID change status when the brake pedal is pressed and released?
 - Yes - proceed to Step 2.
 - No - diagnose the brake pedal switch output and repair outside of this article. Refer to WSM, Section 307-05.
- Is the vehicle built on or before 08-Sep-2025?
 - Yes - proceed to Step 3.
 - No - This article does not apply. Refer to WSM, Section 307-05.
- Remove the left console trim to inspect the GSM build date. Refer to WSM, Section 501-12. (Figure 1)

- Verify the GSM build date/Julian Date. Refer to Table 1.

6. Replace the GSM. Refer to WSM, Section 307-05. WSM, Section 307-05 includes performing the PMI procedure to install the latest strategy files and carry out the TRON Module Authentication Procedure for 2024-2025 vehicles using the FDRS.
