**TECHNICAL SERVICE BULLETIN, VIN:
WSB-05 Open Trail Active Radar Cruise Control Sensor Correction**

Technical Service Bulletin WSB-05 Repair Instructions

Purpose: Replace front active radar cruise control bracket to correct sensor orientation.

Models: 2026 Open Trail Motorhomes

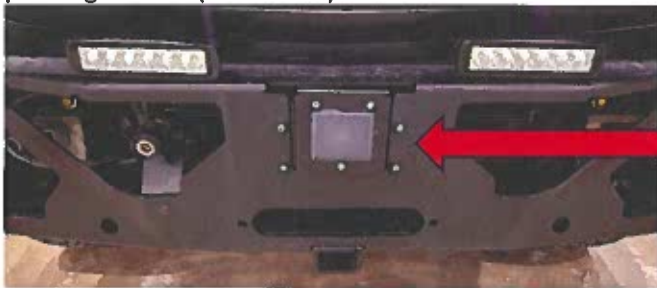
1. Verify the orientation of the current sensor and bracket hole pattern. The correct bracket orientation has two bolt holes on the top side and one bolt hole on the bottom side of the bracket, as seen in figure 1. The incorrect bracket orientation has two bolt holes on the driver's side and one bolt hole on the passenger's side (not shown).

Figure 1, correct bracket shown.
