Technical Service Bulletin

GROUP CAMPAIGN	NUMBER 25-01-068H-1
DATE NOVEMBER 2025	MODEL(S) SEE BELOW

SUBJECT: OIL PUMP UNIT (OPU) SOFTWARE UPDATE - DTC U100787 (SERVICE CAMPAIGN TEK)

Description: Certain Tucson Hybrid (NX4 HEV) and Tucson Plug-in Hybrid (NX4 PHEV) vehicles may exhibit a condition where the Oil Pump Unit (OPU) prevents the Ready Lamp from turning on. Some vehicles may also display DTC U100787 (malfunction on CAN communication). This bulletin provides instructions to perform a software update for the Powertrain Control Unit (PCU).

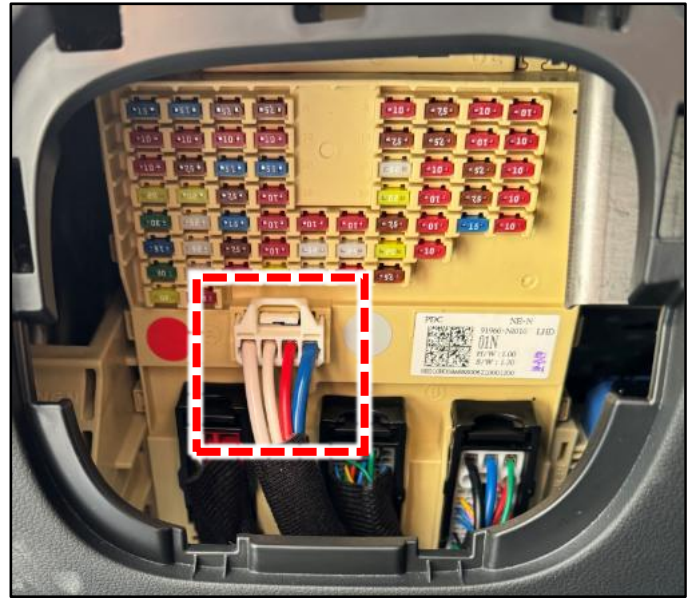
1. Use GDS to scan for **DTC U100787**:
 - If the DTC is **NOT** active, then proceed to **step 2**.
 - If DTC is active, remove the power connector from the in-cabin fuse box for at least **10 seconds**, then reconnect it.

This step re-establishes communication between OPU and ECU for update to successfully execute.

Alternatively, disconnect the negative (-) **12V** battery terminal, wait at least **10 seconds**, then reconnect it.
