Technical Service Bulletin

GROUP CAMPAIGN	NUMBER 25-01-070H-1
DATE NOVEMBER 2025	MODEL(S) PALISADE (LX2)

SUBJECT: ABS SOFTWARE UPDATE
(SERVICE CAMPAIGN 9C8)

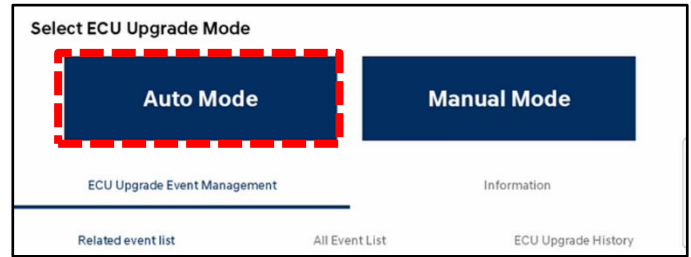
1. Perform the ECU update in **Auto Mode**.

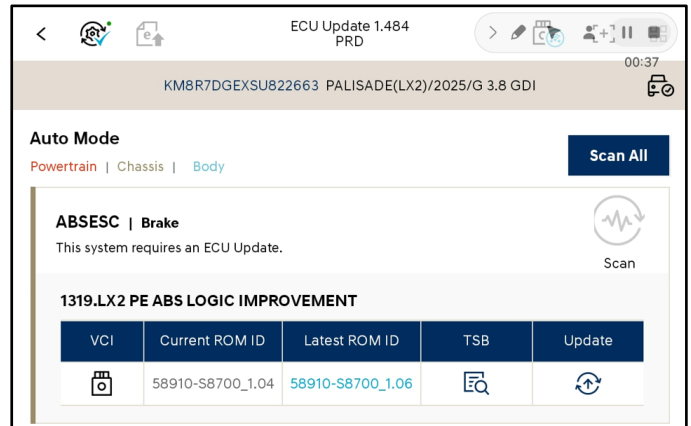
2. Verify the ROM ID by selecting the **ABSESC** system to scan the vehicle’s current ROM ID.

Check the current ROM ID version and compare it to the ROM ID Information table before attempting to perform the software update.

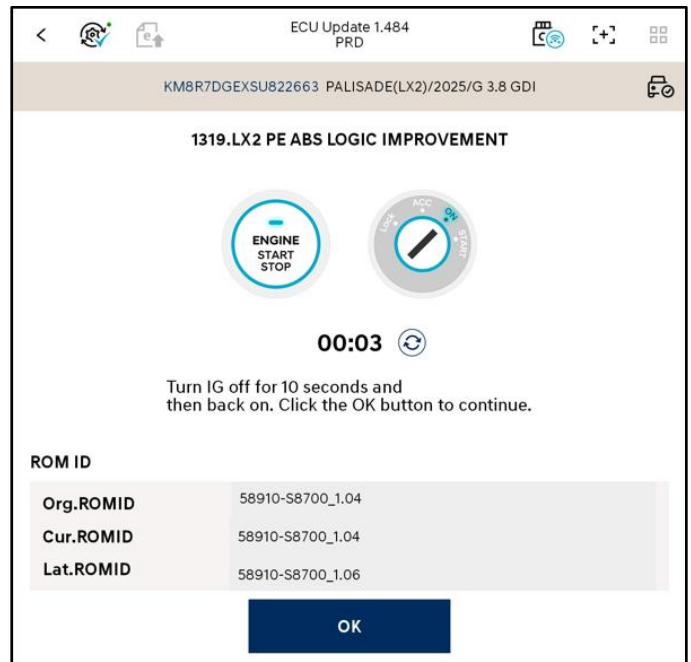
3. After the ECU update process shows 100% complete, follow the prompts on the screen to cycle the ignition **OFF** for at least **10 seconds** to reset the control unit (certain models may take up to **30 seconds**).

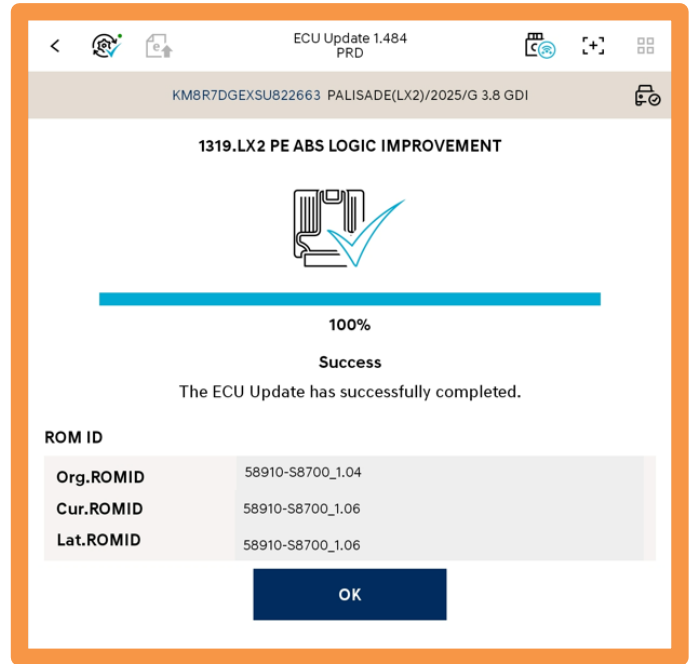
Using the tablet or GDS screen capture function, take a screenshot of the ECU Update “Success” result screen.

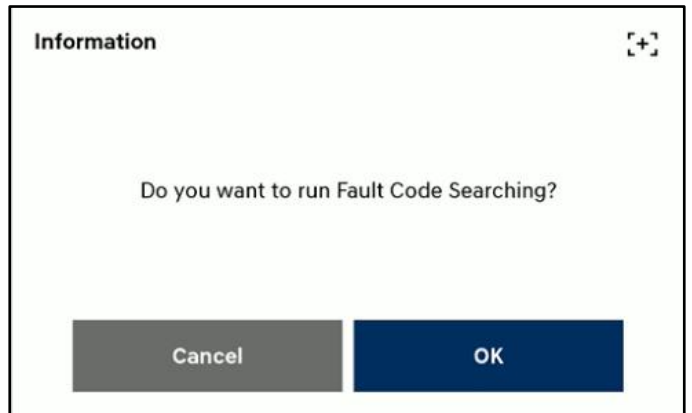
5. Perform an **All Systems Fault Code** search and erase DTC history that had incidentally occurred from the ECU update.
