Technical Service Bulletin

GROUP SUSPENSION	NUMBER 25-SS-003H
DATE NOVEMBER 2025	MODEL(S) SANTA CRUZ (NXT)

SUBJECT: REAR SUSPENSION CLUNK OR THUMP NOISE -
REAR SHOCK ABSORBER REPLACEMENT

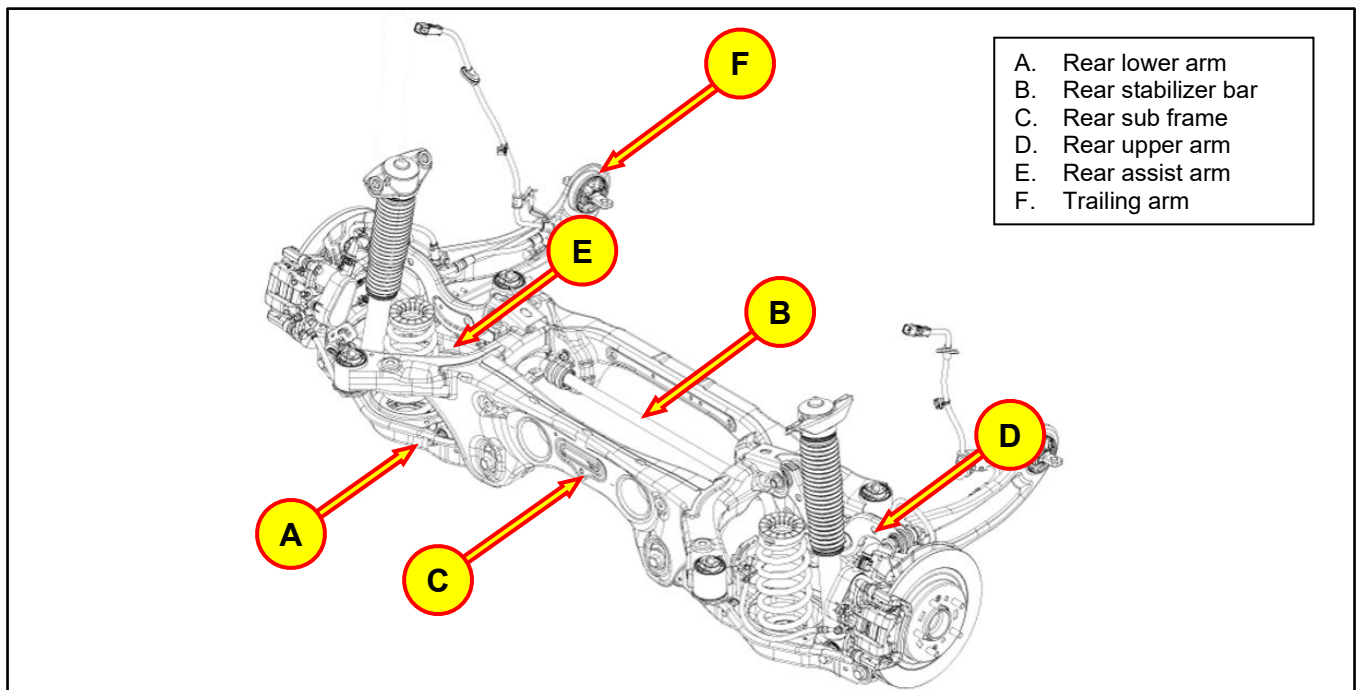
3. Visually inspect rear suspension components listed below for visible issues, damage, etc.

- If **NO** damage or visible issues are found with any components, then both rear shock absorbers (G) **MUST** be replaced. Proceed to [Shock Absorber Replacement](#).
- If damage or issues are found, diagnose and repair as necessary. Then retest for the clunk/thump noise.
 - If the noise is resolved, then the service procedure is complete.
 - **If the clunk/thump noise is still present**, then proceed to [Shock Absorber Replacement](#).

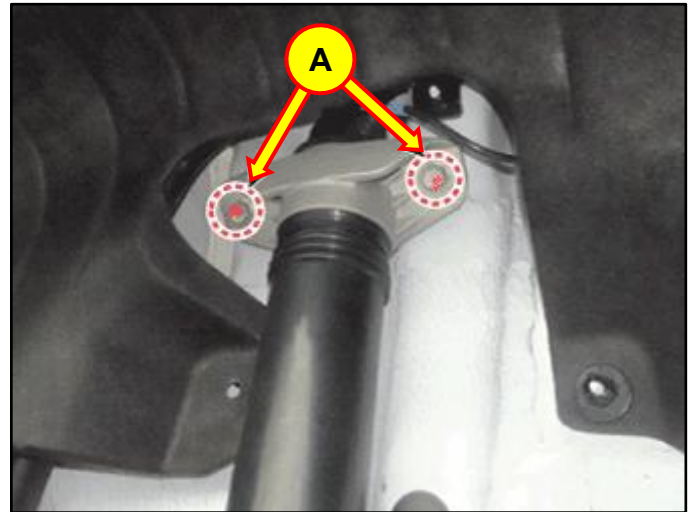
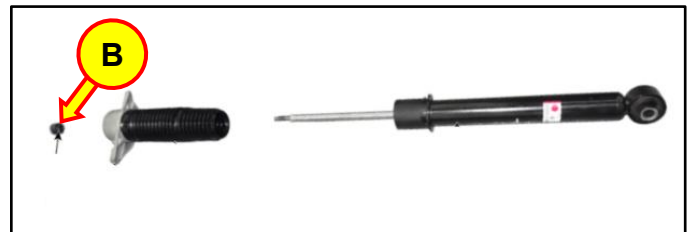
Be sure to replace the lock nut (B) with a new part. Do **NOT** reuse it.

1. Replace both rear shock absorbers with the new parts.

**Tightening Torque -
Shock Absorber Mounting Bolts (A):**

lb-ft	94
N.m	127

**Tightening Torque -
Shock Absorber Lock Nut (B):**

lb-ft	16
N.m	22
