Technical Service Bulletin

GROUP CAMPAIGN	NUMBER 25-01-061H-1
DATE NOVEMBER 2025	MODEL(S) TUCSON (NX4A)

SUBJECT: DCU SOFTWARE UPDATE
(SERVICE CAMPAIGN TDFC)

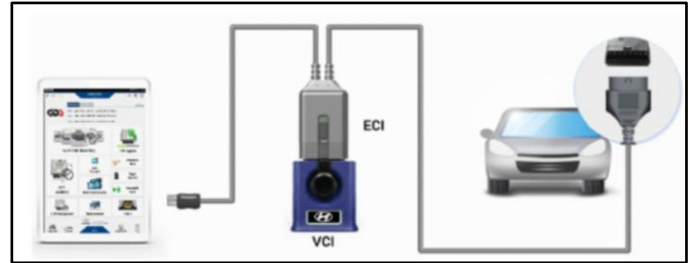
VCI 2 Connection (must use ECI kit with USB-C cable attachment):

1. Connect the ECI DLC connector to the OBD connector of the vehicle.
2. Connect the VCI to the receiver module on the ECI cable.
3. Connect the ECI cable with the USB-C connector cable attachment to the tablet.

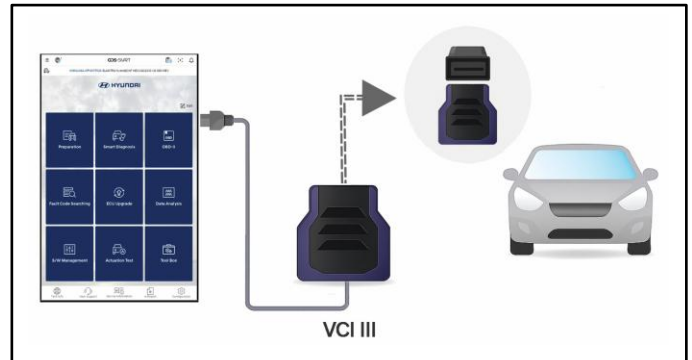
VCI 3 Connection (use VCI 3 cable):

1. Connect the 19-pin connector to the bottom of the VCI 3.
2. Connect the VCI to the OBD connector of the vehicle.
3. Connect the cable with the USB-C connector to the tablet.

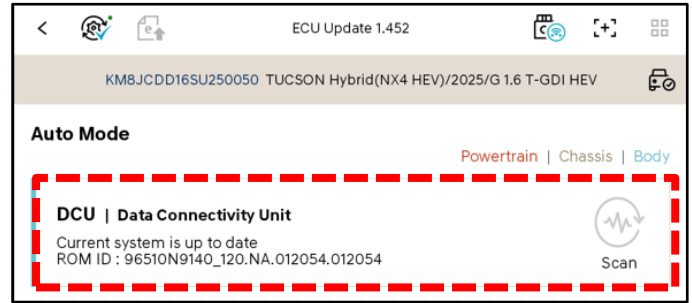
The screenshots within this service procedure refers to Tucson Hybrid, but is also applicable to Tucson Internal Combustion Engine (ICE) vehicles.

- After the ECU update process shows 100% complete, follow the prompts on the screen to cycle the ignition **OFF** for at least **10 seconds** to reset the control unit (certain models may take up to **30 seconds**).

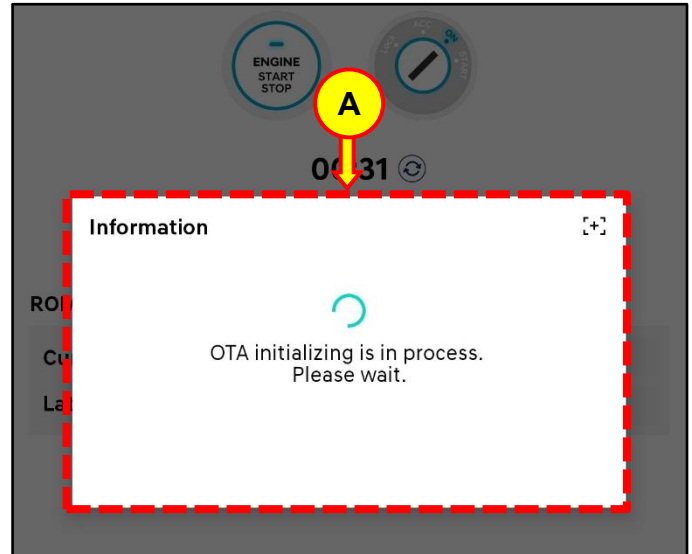
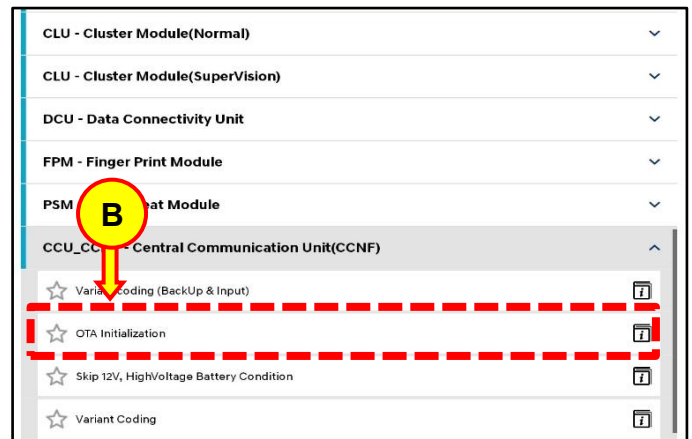
5. OTA initialization (A) should perform automatically:
 - If OTA initialization performs automatically, then proceed with the service procedure.
 - If the OTA initialization process fails, complete it manually under:
 - S/W Management > CCU_CCNF - Central Communication Unit (CCNF)**
 - > OTA Initialization (B).**

Follow the instructions on the screen.

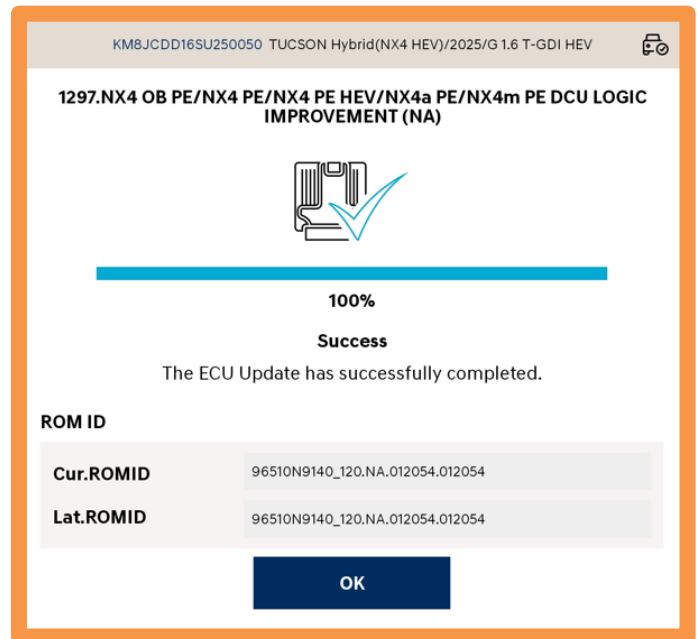
Using the tablet or GDS screen capture function, take a screenshot of the ECU Update "Success" result screen.

Upload the photo to STUI.

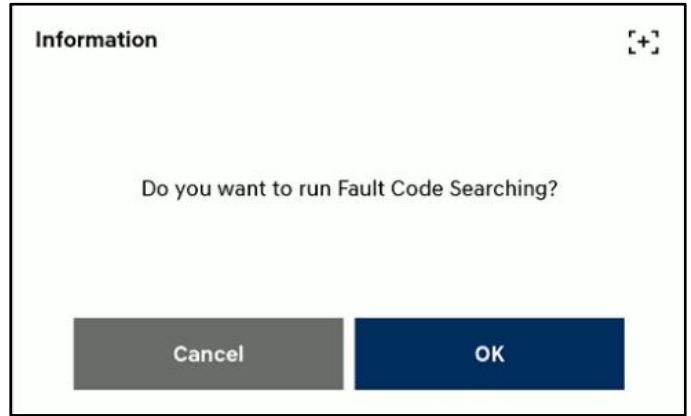
7. Perform an **All Systems Fault Code** search and erase DTC history that had incidentally occurred from the ECU update.
