Service Bulletin

Bulletin No.: 24-NA-166

Subject: DTC C1171 C1172 C1173 C1174 Tire Pressure Monitor Sensor Unable to Relearn Ethernet Cable Overlay for TCP OnStar Module

Brand:	Model:	Model Year:		Build Date:		Engine:	Transmission :
		from	to	from	to		
Buick	Enclave	2025	2026	SOP	October 29, 2025	—	—
Chevrolet	Traverse	2024	2026				
GMC	Acadia	2024	2026

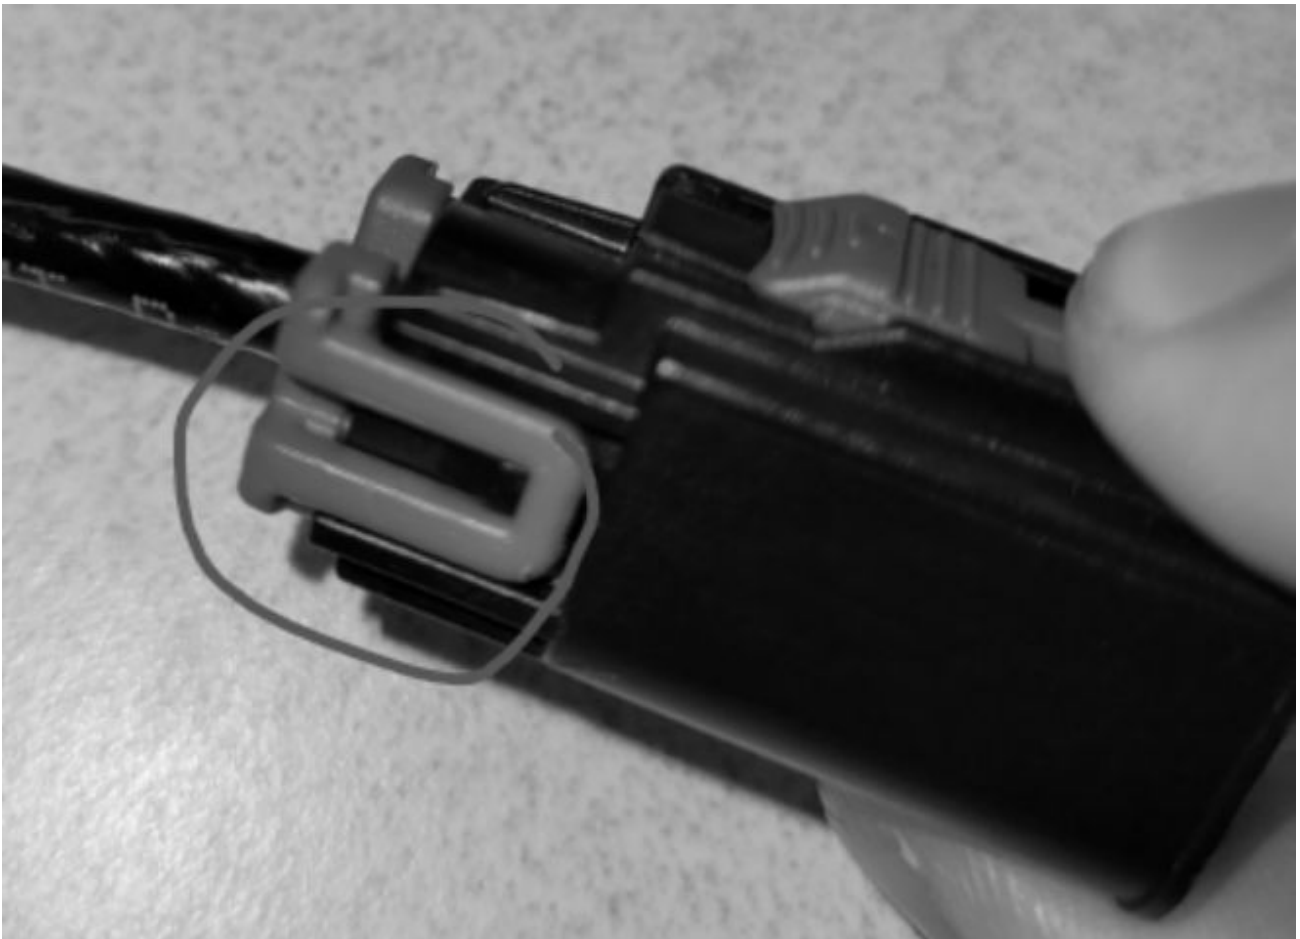
6720403

Empty housing shell. Circle in red is the 1 release tab. Arrow shows the direction the tab needs to be pressed to release the cable, moving it away from the middle.

15.1. Remove the rear clip by releasing both clips from the outer housing and remove it.

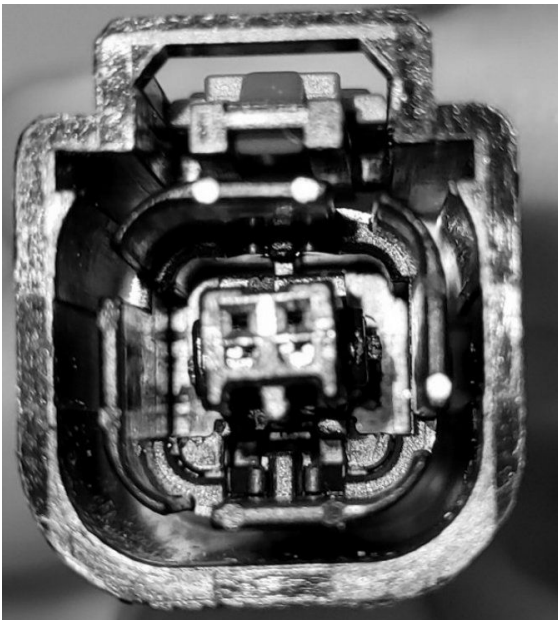
6720432

Following the middle ridge to the back, this is where the housing locks onto the cable.

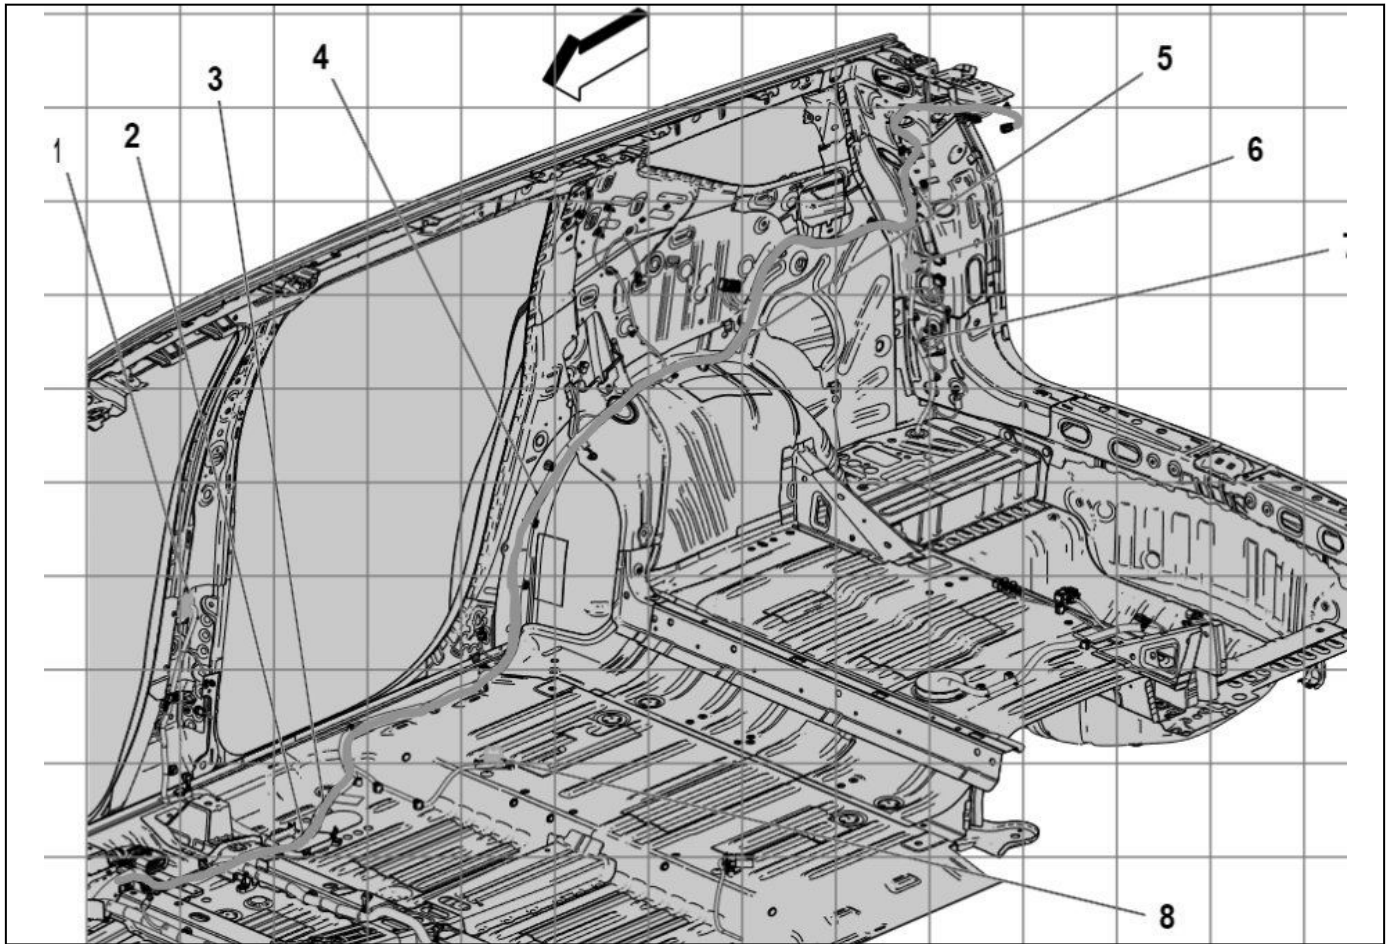
6706066

Note: Replacement Ethernet Cable routing shown in Green.

18. Begin to route the new Service cable starting at X205 and following the Body Wiring Harness running back towards the Telematic Control Module. Use the diagrams above to reference cable routing.
