Technical Journal

PS3 Uneven Temperature from the vents

REF NO: TJ 37558.1.0	ISSUING DEPARTMENT: Technical Service	CAR MARKET: United States and Canada	
PARTNER: 3 US 7515 Polestar		ISSUE DATE: 2025-10-24	STATUS DATE: 2025-11-06
FUNC GROUP: 8720	FUNC DESC: Air distribution	Page 1 of 3

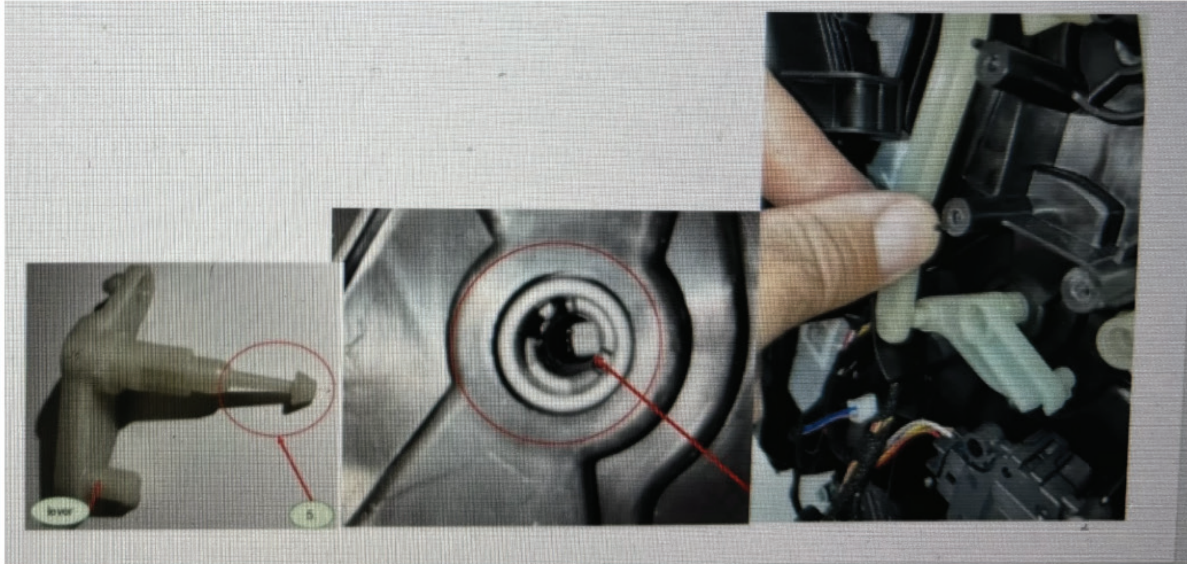
Inspecting climate box lever

If customer complains of uneven temperature in front section with Climate set LO-LO and left side is warmer than right side, please follow advice under service.

Remove the knee bolster airbag to gain access to the left side of the climate box and inspect the blend lever according to attached picture.

If the lever is loose, push it in to ensure it clicks into the climate box. Then check if the symptom is still present.

- 1 Remove the panels below the steering column and remove the knee bolster airbag to expose the left side of the climate box. Then ensure the linkage shown in the picture above is pushed in all the way.
