Service Bulletin

Bulletin No.: 24-NA-227

Subject: Vibration, Rattle or Boom at 1800 to 2000 RPM

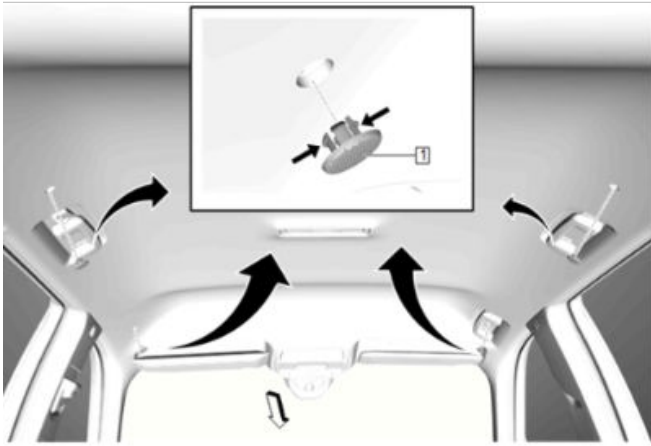
7004221

1. With the car in Drive and the brakes firmly applied, raise the engine RPM to the range the customer hears it in. Once the vibration is active, maintain the RPM and crack open the driver's door. This will disable the ANC system. If the vibration went away, continue to step 1.1. If the vibration remains, continue to step 2, Calibration Update.

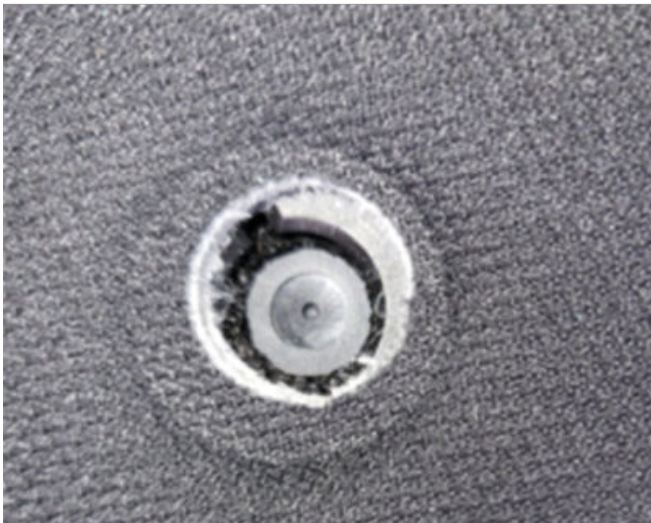
7004222

1.1 Use a suitable plastic trim tool to release the retaining tabs and remove the ANC microphone grilles (1) from the headliner. Look for any microphones not present, or out of position. The mic shouldn't move if gently pushed. It may be necessary to hold the microphone in the retainer when reinstalling the microphone grille, so it doesn't separate the retainer from the back of the headliner.

1.2 Follow *Headlining Trim Panel Removal and Installation* in SI for instructions on how to lower the headliner. The headliner does not require removal to access ANC microphones. Only lower the corner(s) that require the microphone to be properly retained.

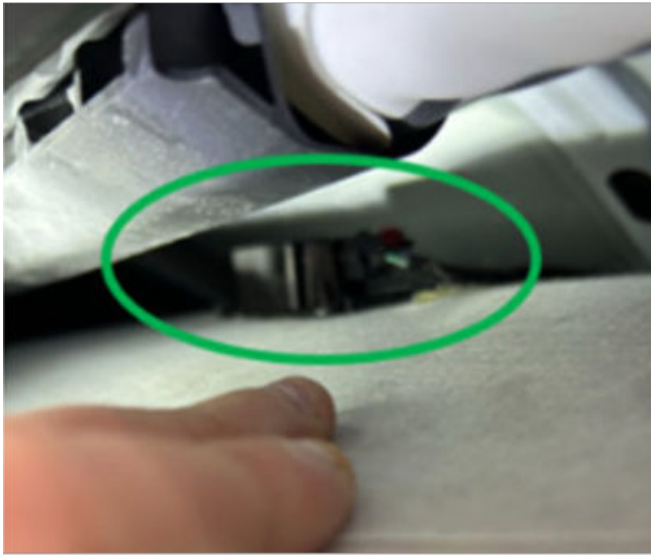
7004223

Example of properly located ANC microphone, shown below:

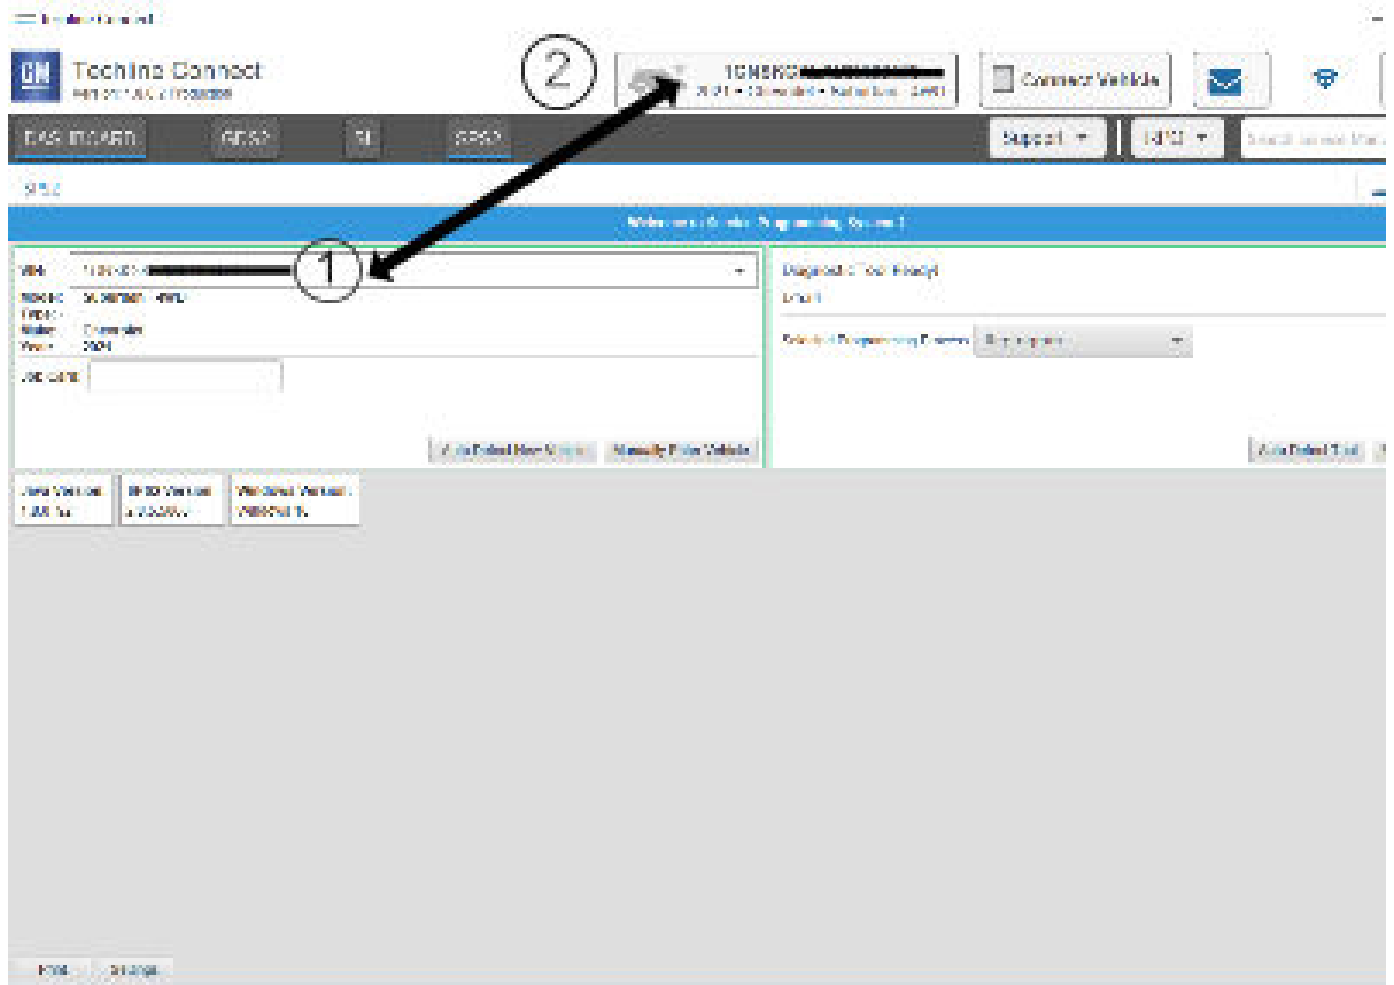
5743643

Caution: Be sure the VIN selected in the drop-down menu (1) is the same as the vehicle connected (2) before beginning programming.

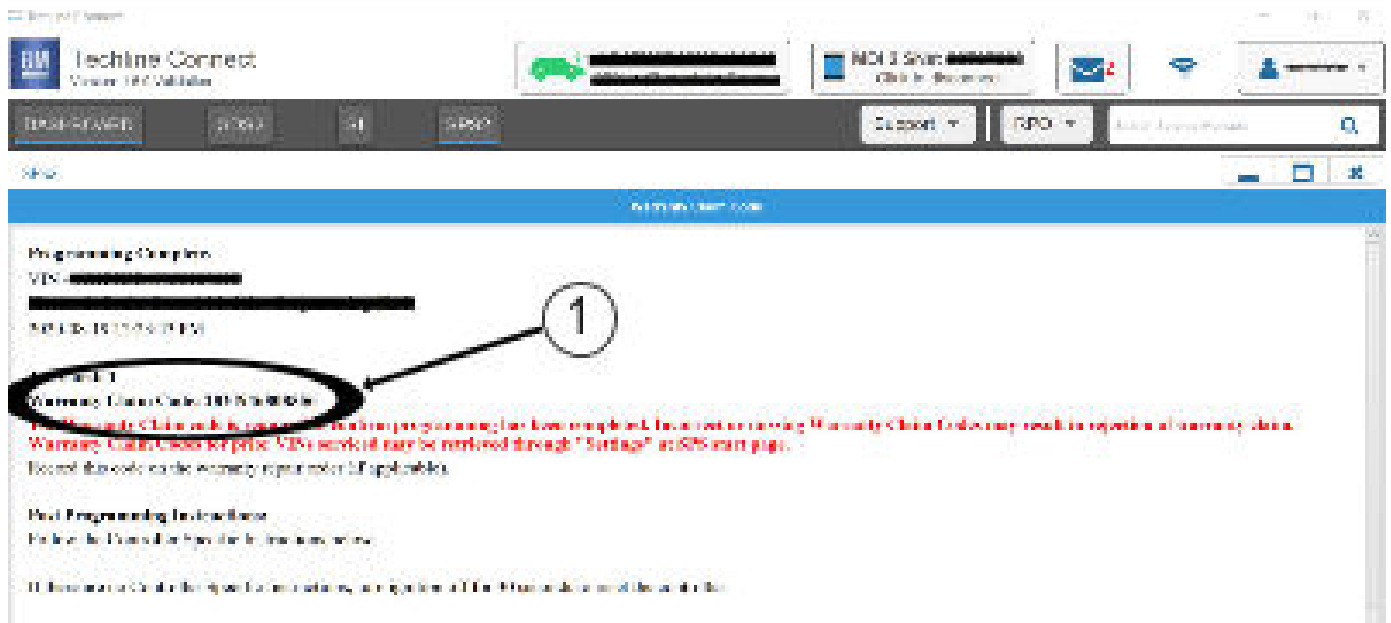
5644478

Important: To avoid warranty transaction rejections, you **MUST** record the warranty claim code provided on the Warranty Claim Code (WCC) screen shown above on the job card. Refer to callout 1 above for the location of the WCC on the screen.

2. Record the SPS Warranty Claim Code on the job card for warranty transaction submission.
3. Confirm proper ANC operation by following the Step 1 test method in the service bay. If the condition is corrected, return the vehicle to the customer. If it is not corrected, continue with SI diagnosis.
