Preview Solution CBR-2408-15

Air Production Modulator (APM) DTC C10129B - High/Excessive Flow - VN (4) - PR (4)

Published 10 November 2025

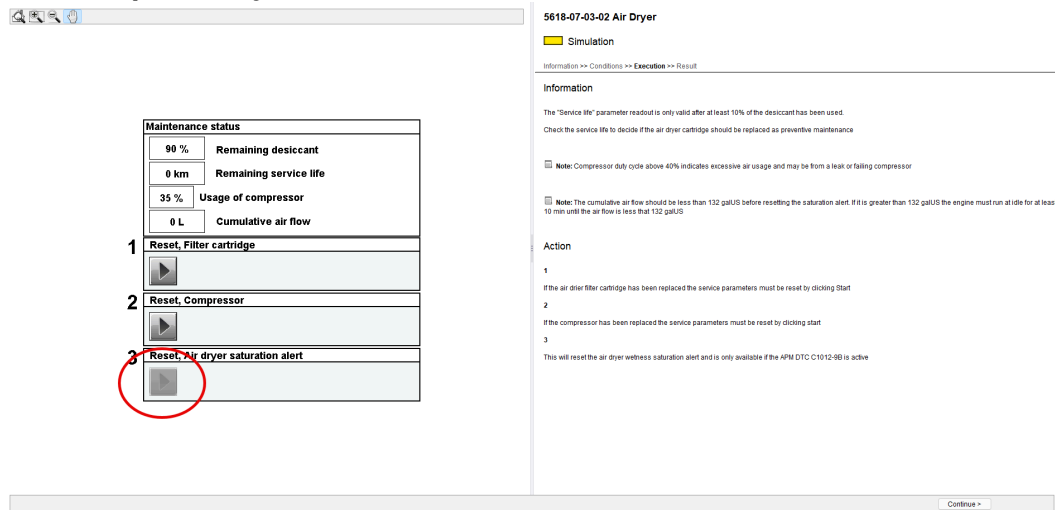
Note: Step 3 is only available if code C10129B is active.

- 5. Begin TT operation 5618-07-03-02 Step 3.**
