Preview Solution CBR-2514-2

Lost Communication to Alternator Message - DTC C103508

Published 11 November 2025

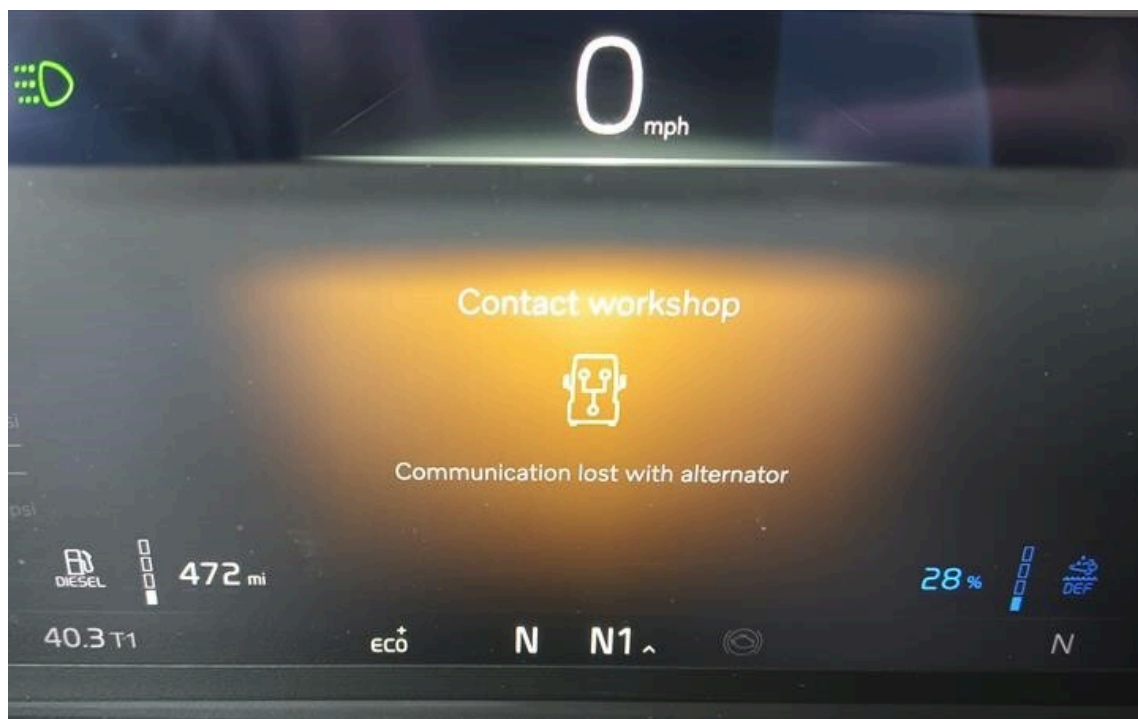
A “**Lost Communication to Alternator**” message may be displayed, and **VMCU DTC C103508** may be active.

This condition is caused by a **software issue** in the VMCU.
