Preview Solution CBR-2525-2

Exhaust Leak or Noise – Turbo Compound (TC) Bolt Inspection and Repair - VN (4), PR (4)

Published 10 November 2025

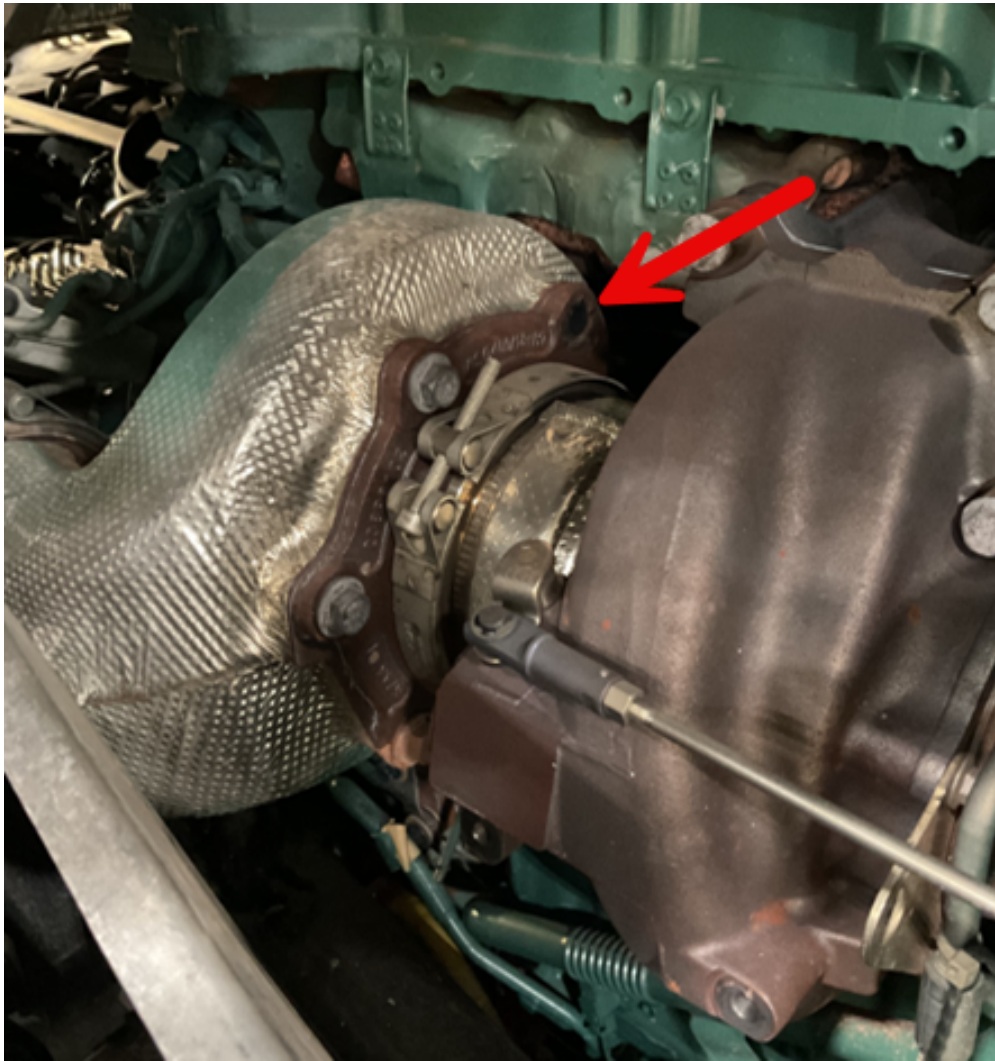
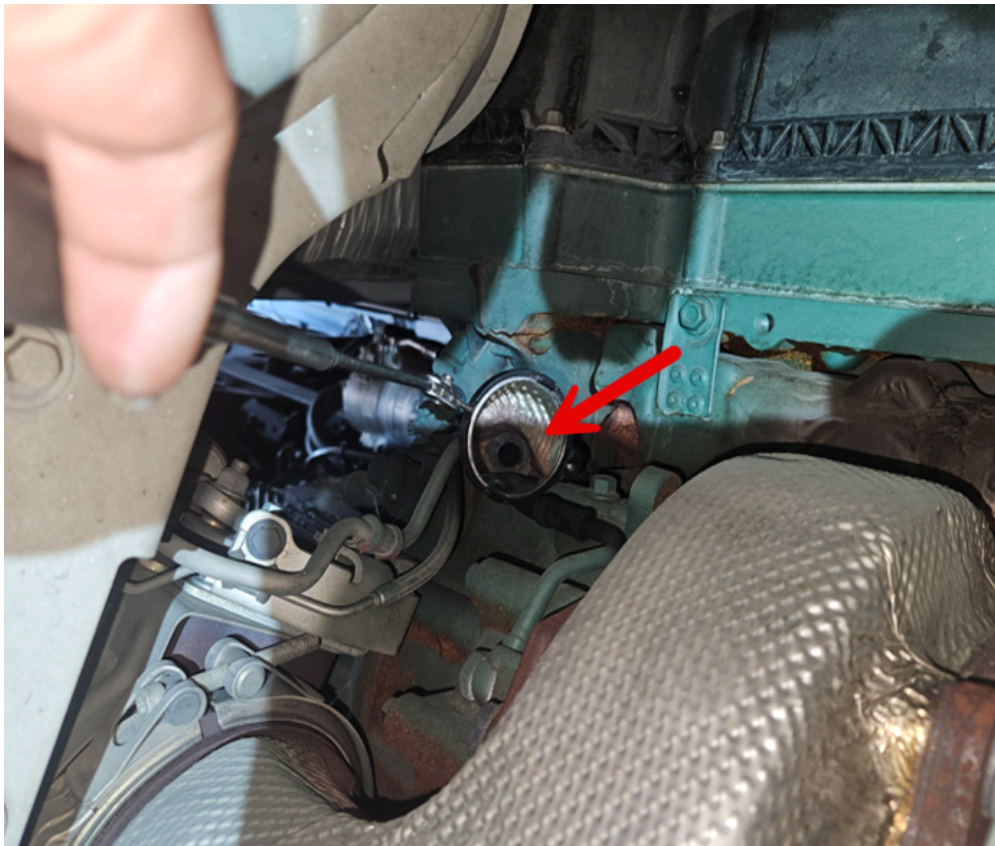
Missing or loose bolts may be present in the exhaust collector section of the TC unit, leading to exhaust leaks or noise.

1. Inspect the exhaust collector section of the TC unit for any missing or loose bolts.
2. If bolts are loose or missing, replace with new fasteners.
3. Use the following fastener for replacements:
 - **Part Number:** 24178977
 - **Description:** M12x30 Bolt with Micro- Encapsulated Locking Fluid
 - **Quantity:** As needed
