Preview Solution CBR-2529-1

## Volvo Chassis - Steering Wheel Switch Harness Routing And Clipping - VN (4)

Published 13 November 2025

Volvo Chassis - VN (4)

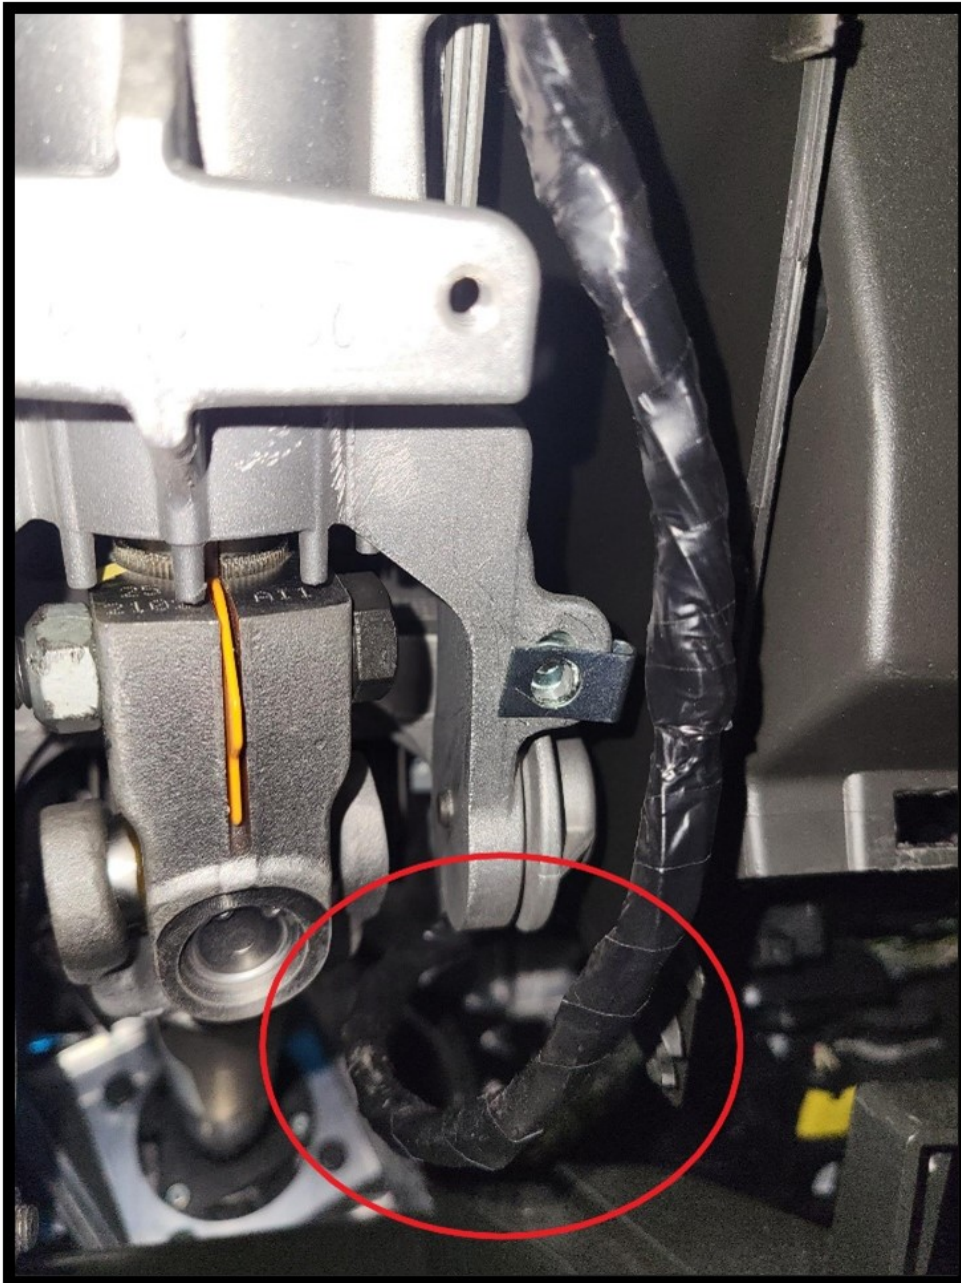
The harness may become unsecure and could be damaged, causing steering wheel switches to become non-functional and/or a vehicle malfunction light.

4. Inspect the steering wheel harness for damage caused by contact with the steering shaft.

5. If harness damage is found refer to Impact operation titled "Wiring Repair" under function group 371 to repair the harness. If no damage is found continue to next step.
