Preview Solution CBR-199-6

13 Liter Engines ONLY - Engine Coolant Pump Housing Leak; Coolant Found Around The Oil Cooler Duct Cover Or In Between The Coolant Pump Housing And Oil Cooler Housing

Published 11 November 2025

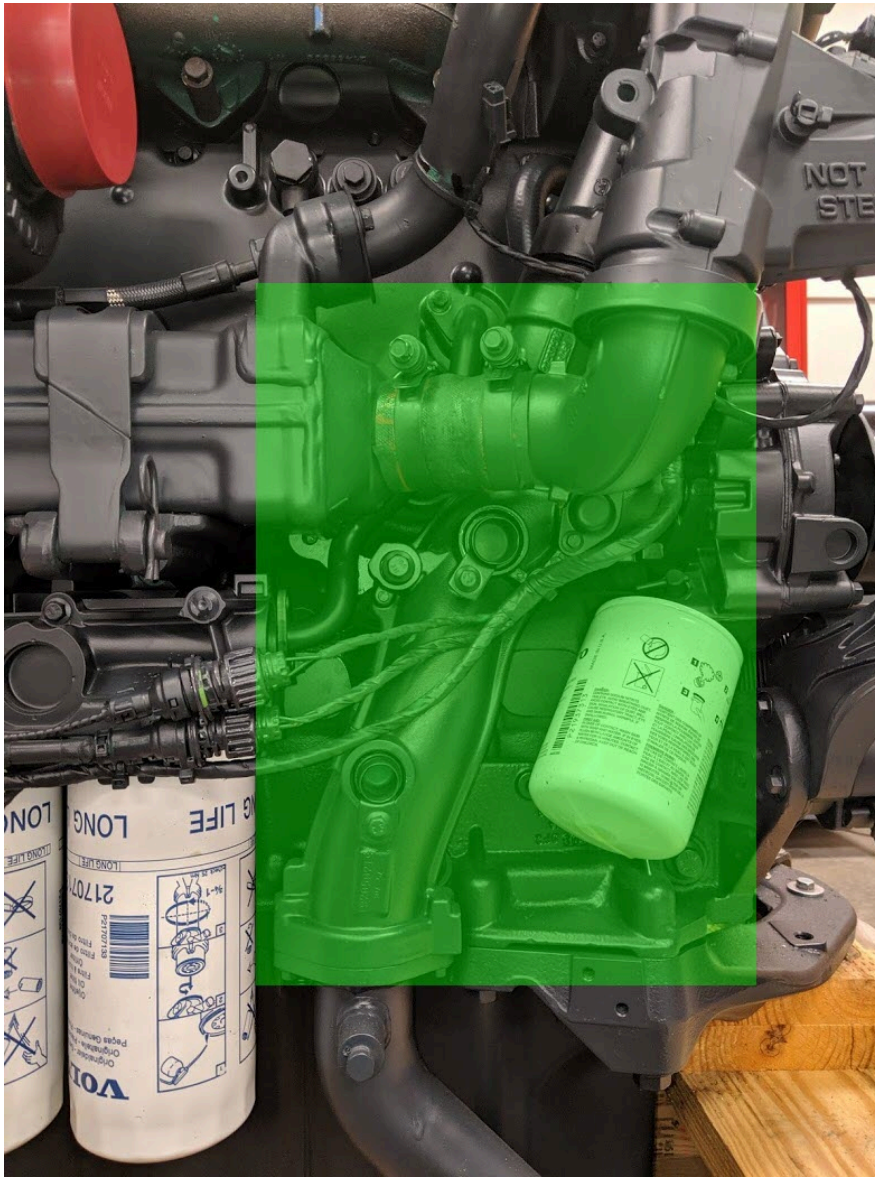
Vehicles affected by this issue will show coolant runoff on the front rights side of the engine. The likely area coolant will be found is highlighted below:

- Replace the coolant pump cover.
- Replace the seal between the oil cooler duct cover and the coolant pump.

Note: Ensure the seal is properly seated when reconnecting the housing and duct cover. If the seal is improperly seated, leakage may persist after repairs are complete.

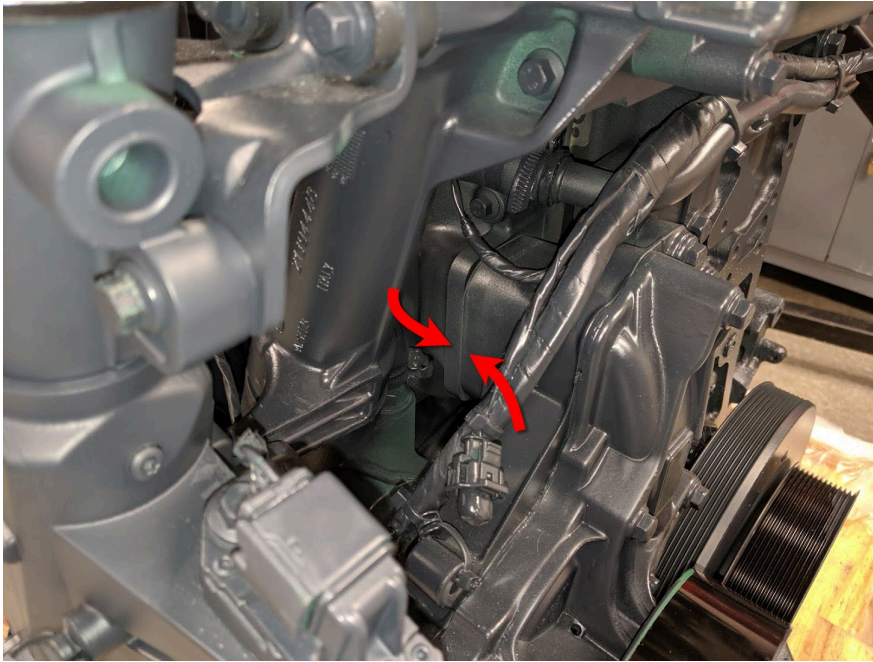
The joint between the coolant pump housing and oil cooler duct cover should be checked:

If a vehicle presents with a coolant leak in the area shown and the source of the leak is traced to the surfaces between the oil cooler duct cover and the coolant pump housing:
