Service Bulletin

Bulletin No.: 24-NA-262

Subject: Diagnostic Tip for 10L1000 Transmission Noise

Brand:	Model:	Model Year:		VIN:		Engine:	Transmission :
		from	to	from	to		
Chevrolet	Silverado 2500HD/ 3500HD	2020	2025			L5P, L8T	MGM, MGU, MKM
GMC	Sierra 2500HD/ 3500HD

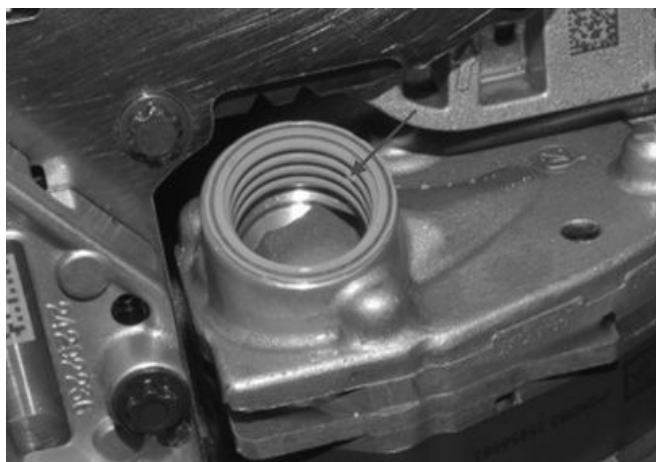
6769556

Park-Transmission Oil Pump Aeration/Cavitation

Aeration is the introduction of air into the transmission fluid (pump inlet).

Erratic whining sound due to uneven distribution of air.

Cavitation occurs when cavities are formed due to a drop in fluid pressure (outlet).

Rattling, whirling/roaring or grinding sounds are all possible.

75°C (167°F) Pump Aeration Cavitation 900 RPM Steady State

75°C (167°F) Pump Aeration Cavitation 650-1500 RPM Sweep

Common Causes:

- Low fluid level
- Plugged/mis installed filter

- Torn/damaged filter O-ring
- Transmission running max line pressure due to DTCs

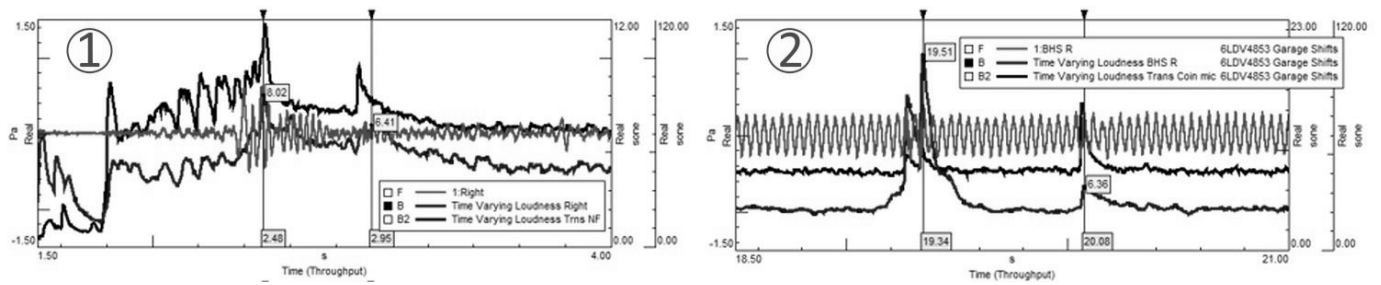
6769524

Start Up/Garage Shift Clunk

Described as an infrequent audible thud that delayed 400–700ms after either a key start or garage shift event.

Severity of thud depends on the load that's placed on the driveline.

Previous root cause work determined noise is related to the C2 clutch application at high line pressure causing the rotating components in park to stop too quickly.

Key Start

Garage Shift

C2 clutch calibration has been modified to assure the C2 knockdown area is pressurized in park and neutral when C2 is being applied.

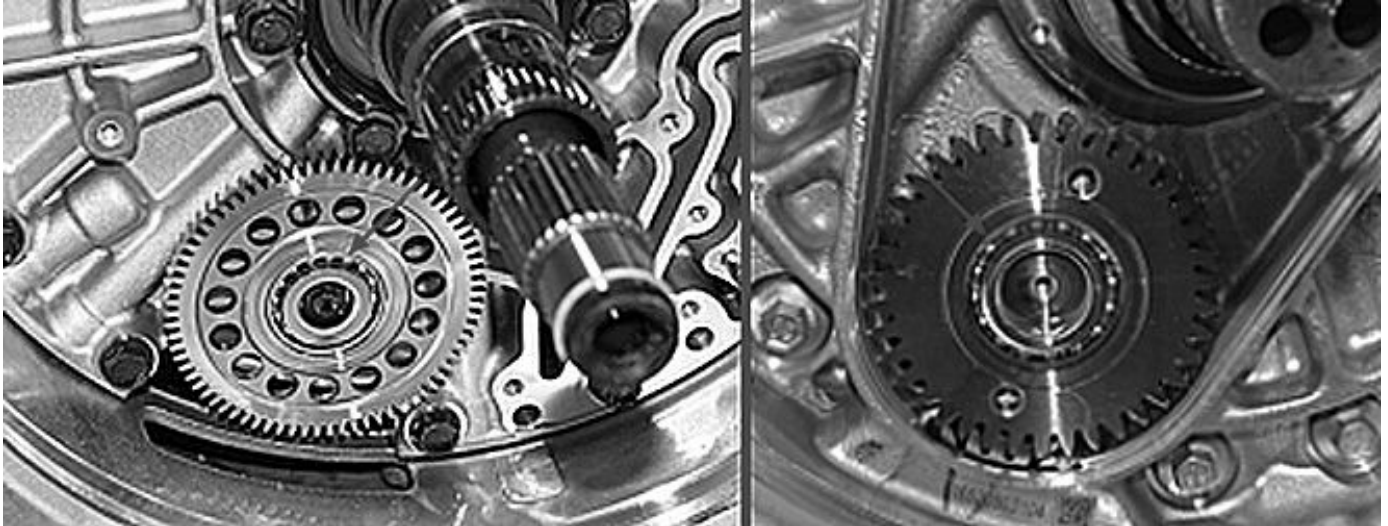
6769588

Underbody Gear Rattle (7th Gear Only)

While rare, rattle during light acceleration (10–15% throttle) in 7th gear only may be observed.

Size of the idler gear inner diameter can affect the interference fit of the pressed in bearing reducing the overall axial/radial clearance of the bearing balls.

The gear free lock will increase or decrease depending on that interference fit:

- High interference fit can create gear rattle
- Low interference fit does not produce rattle

Increasing line pressure can reduce rattle by overcoming the drag torque.
