Service Bulletin

Bulletin No.: 24-NA-272

Subject: Park Assist False Alerts on Z71 Traverse

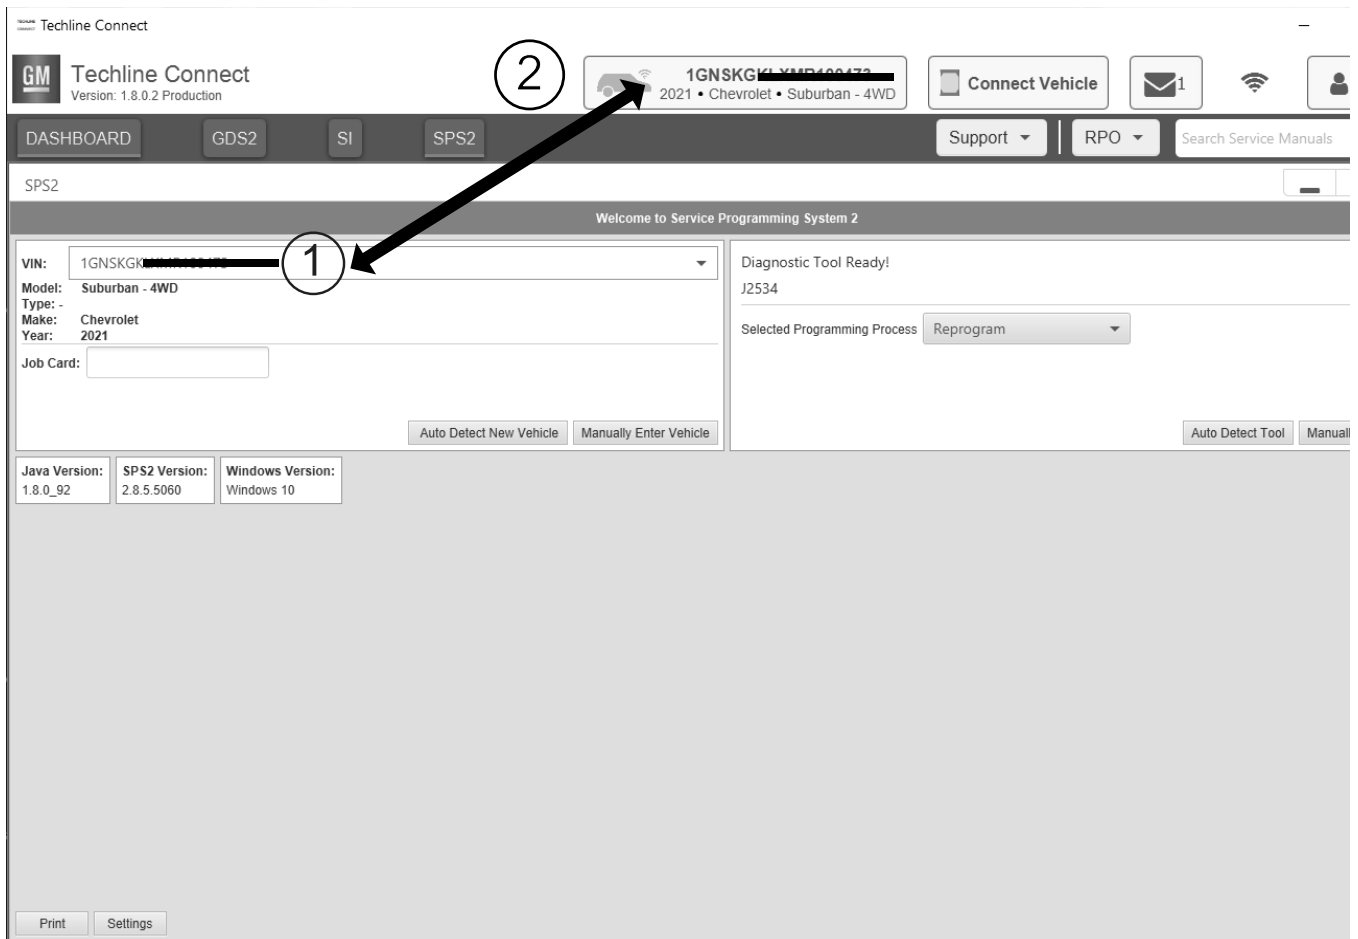
5743643

Caution: Be sure the VIN selected in the drop-down menu (1) is the same as the vehicle connected (2) before beginning programming.
