Exhaust Gas Flap Noise - OM654

Topic number	LI49.00-N-080010
Version	1
Function group	49.00 - General
Date	11/21/25
Validity	OM654
Reason for change

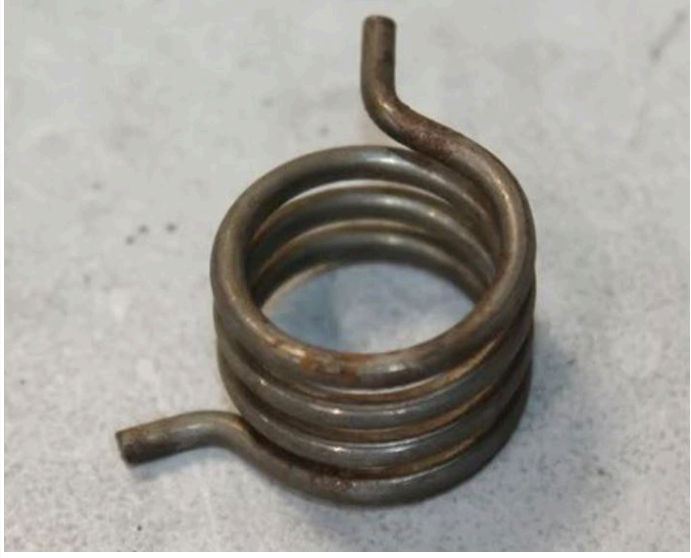
File	Description
Photo 1.JPG

The noise occurs during actuation of the exhaust gas flap. Internal movement within the flap mechanism, primarily the flap shaft and return spring, can generate friction-induced squeal.

Spring for exhaust gas flap actuator
Photo 2.jpg

- Remove the original spring (Picture 1).

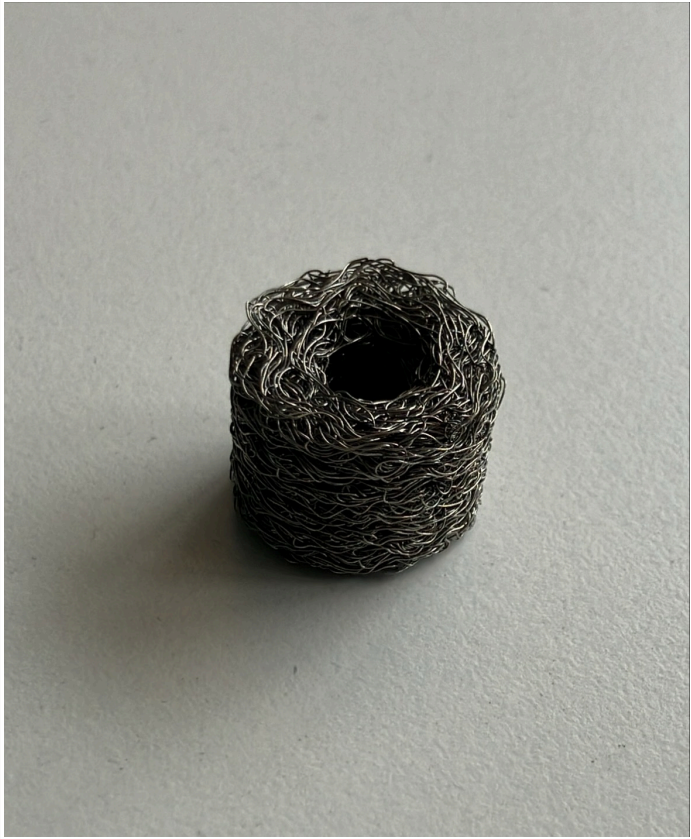
Damping element for exhaust gas flap actuator

- Install the new damping element in place of the spring (Picture 2 and Picture 3).

-This damping element absorbs vibration and prevents squealing, eliminating the need for costly component replacements.

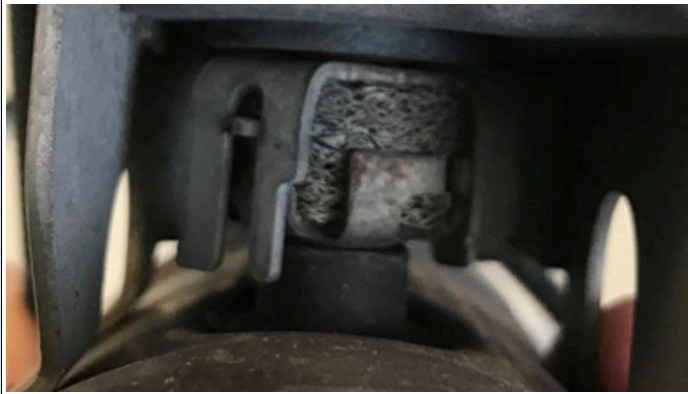
Photo 3.JPG

Installation position of damping element
