Diverse messages in the instrument cluster, vehicle will not start, gears cannot be engaged

Topic number	LI54.21-N-069524
Version	7
Function group	54.21 - Control units / basic modules
Date	11/11/25
Validity	MODEL 907
Reason for change	Addition of pictures for A-pillar seam seal leak

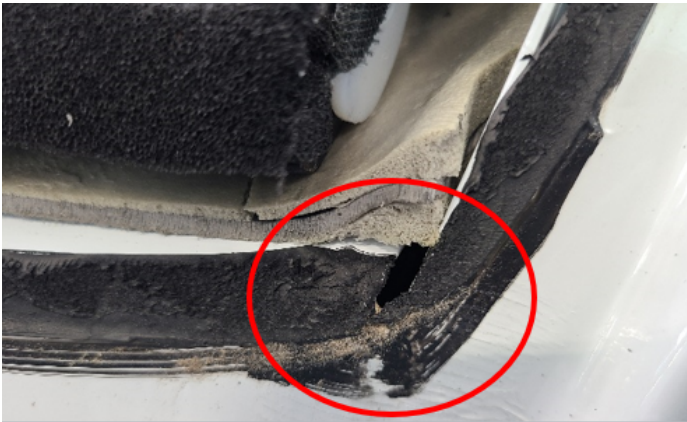
<p>Lower seam seal leak</p>	Gap in lower seam sealant
upper seam sealant leak .png

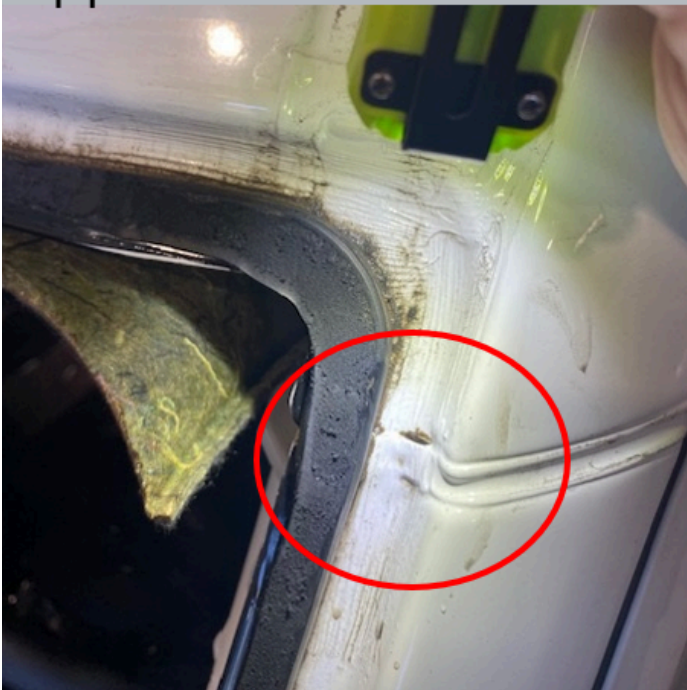
<p>Upper seam seal leak</p>	Gap in upper seam sealant

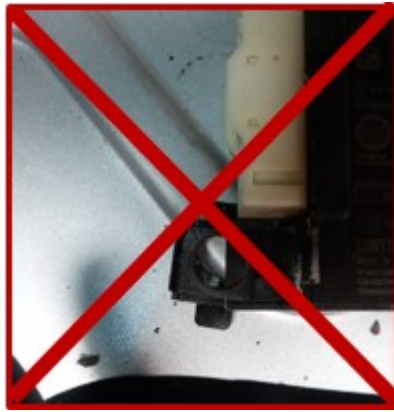
Picture 7

- Slide hole in pocket over the tucker bolt and align pocket such that the opening faces downwards. (See picture 5).
- Spread pocket (see picture 6), slide control unit with upper clip-in point, over the tucker bolt (see picture 9) (Caution, make sure that both clips on the control unit are correctly seated, (wrong clip position in picture 7, correct position in picture 8)
