Model Series 907 - T57 Electric Step will not extend/inoperative

Topic number	LI88.30-N-078036
Version	2
Function group	88.30 - Detachable components, override guard
Date	11/12/25
Validity	907 with T57 Electric Step
Reason for change	Change to damage code

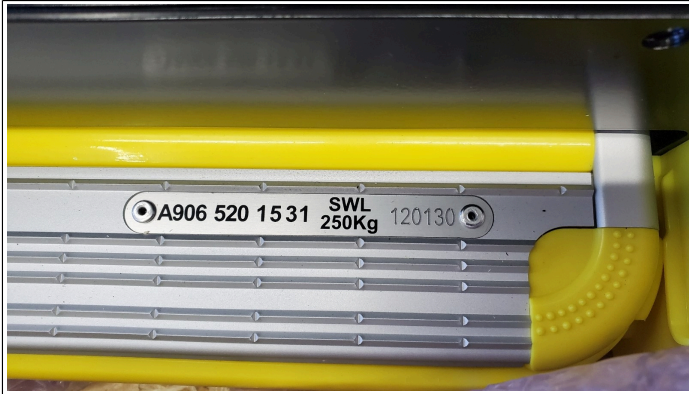
Attachments	
File	Description
Step Serial.jpg	Step Serial Number Location

If damage to end position sensors are found, please check the serial number on step (see attached image of serial number location)

If the serial number is below 126050:

1. Please check that the drive motor is secured to the step properly.
2. Replace the end position sensor/sensors and install them in an adjusted position that allows proper clearance between drive and sensor/sensors. (see attached image of sensor position example.)
3. Function test the step at least 5 times to check for proper clearance.

If the serial number is 126050 or higher:

1. Please open a TIPS case including images of the damaged sensor/sensors and serial number of step.
