# SERVICE ACTION

Global Service Action  
Number: D048

Subject: <b>Jump Start Information Label Missing</b>	Publication No.: D048
	Model: Defender (LE)
	Model Year: 2025 - 2026
	Date of Issue: 18 November 2025
	Expiry Date: 30 November 2027

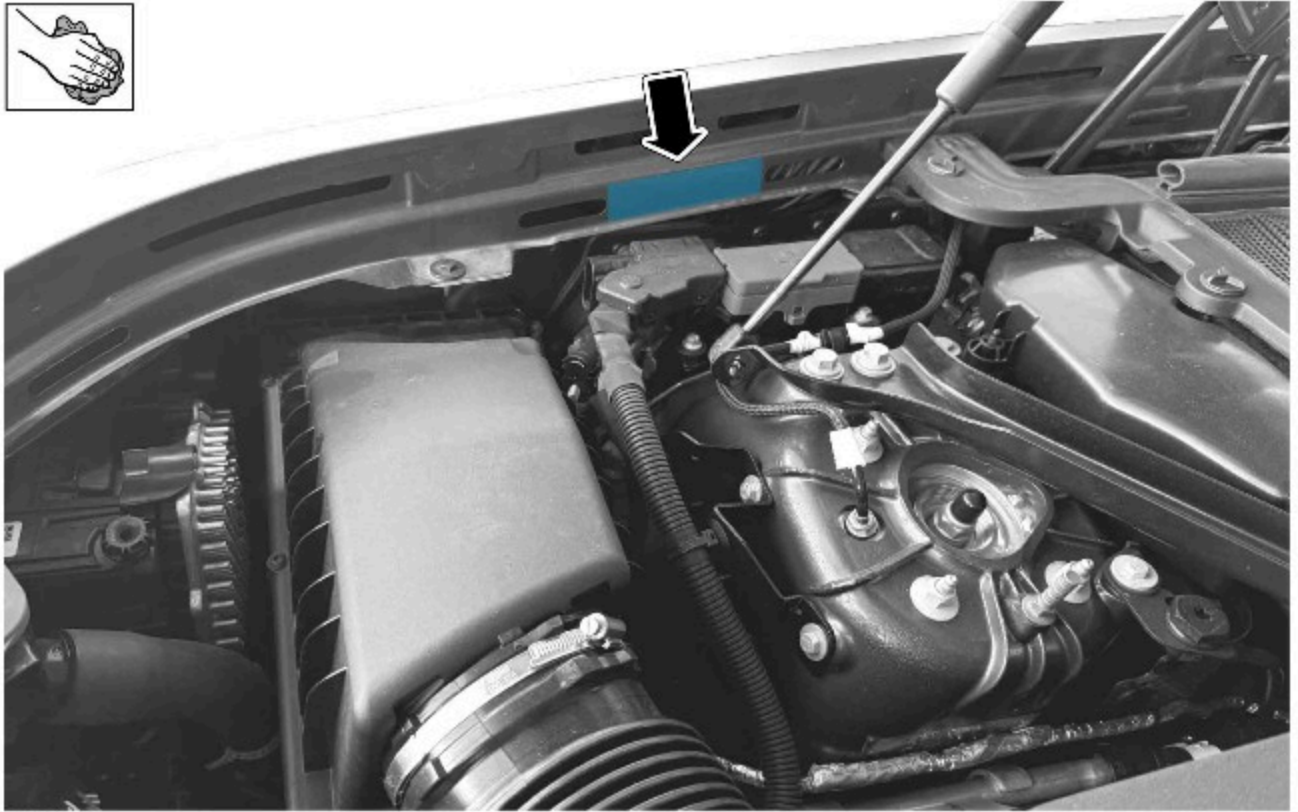
E396423

2. Locate the area on the fender apron panel as shown in the illustration.

- Clean the area using a suitable cleaner.
