JLRTB02127NAS6

TECHNICAL BULLETIN

Engine Coolant Level Low with no Visible Loss of Coolant

MODEL:	MODEL YEAR:	VIN:	ASSEMBLY PLANT:
Range Rover (LK)	2022-2024	000001-234058	Solihull

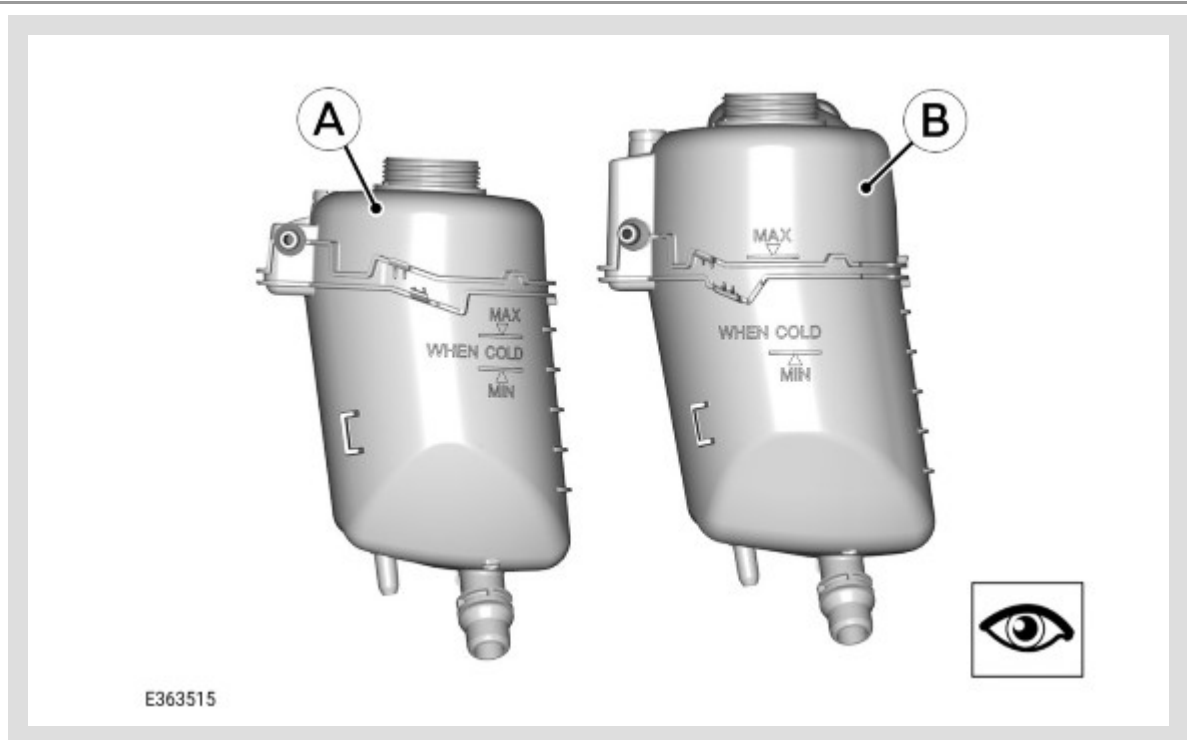
1.

Inspect the coolant expansion tank.

- If coolant expansion tank 'B' is installed **do not** continue with this bulletin. Repair as necessary with reference to TOPIx.
- If coolant expansion tank 'A' is installed continue to the next step.

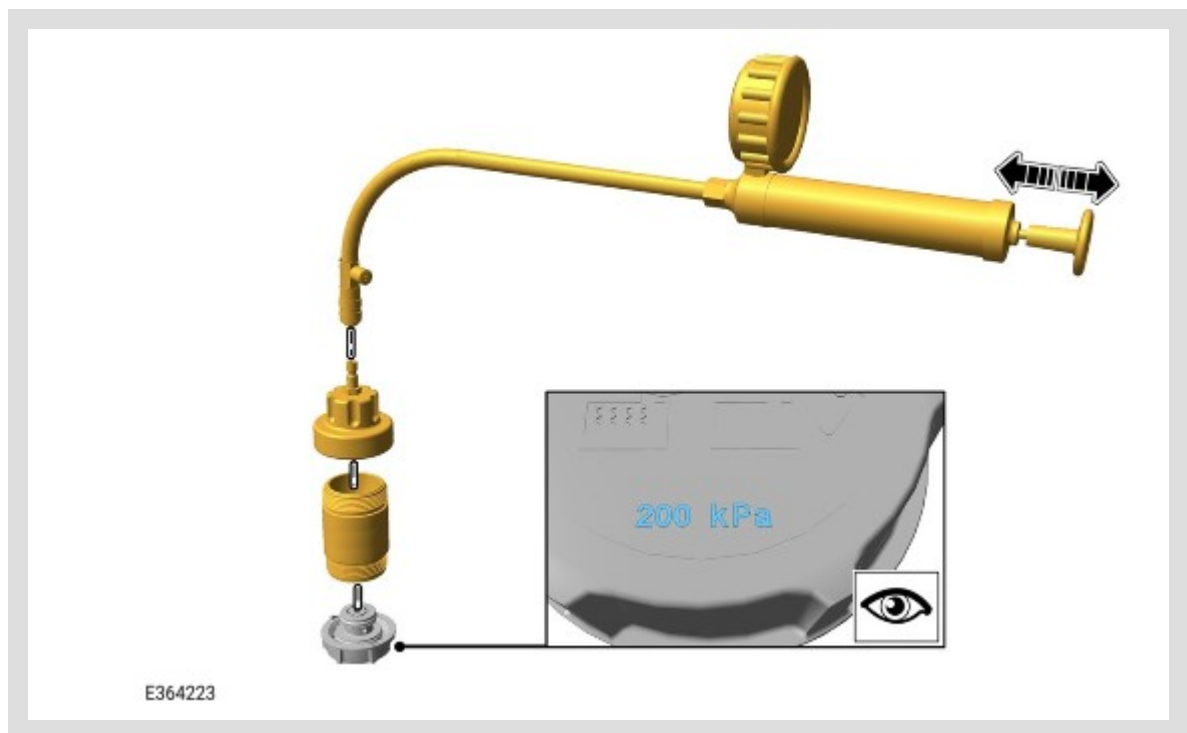
Using the correct adapter connect the cooling system pressure tester to the coolant expansion tank filler cap.

- Slowly pressurize the coolant expansion tank filler cap 1.6 bar (23 psi) as shown on the gauge. No significant drop in pressure must be noted on the coolant expansion tank filler cap. If after 5 minutes the pressure significantly drops, the coolant expansion tank filler cap must be replaced.
- If 1.6 bar (23 psi) is reached with no drop in pressure, validate the coolant expansion tank filler cap by increasing the pressure to between 1.7 bar (25 psi) to 2.1 bar (30 psi) to confirm the valve is operating as intended. The pressure must be released through the coolant expansion tank filler cap.
- If the coolant expansion tank filler cap fails this test, the coolant expansion tank cap must be replaced. This must be completed under related repairs and must be claimed as a separate warranty claim.

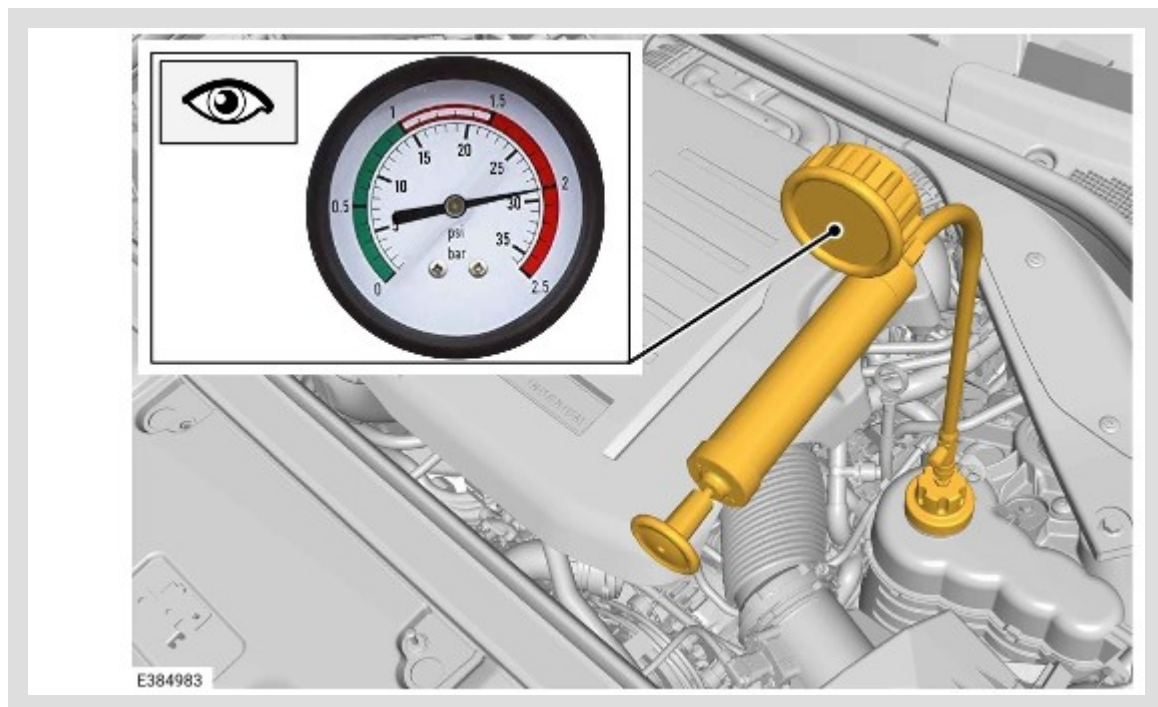
Using the correct adapter connect the cooling system pressure tester to the coolant expansion tank.

- Slowly pressurize the cooling system until 2.0 bar (28 psi) is shown on the gauge.
- No significant drop in pressure must be noted on the cooling pressure tester gauge. If after 5 minutes the pressure significantly drops, inspect the cooling system for leaks. A pressure drop of 0.15 bar (1psi) in the first minute is considered normal operation.
