Technical Service Bulletin

**LIGHT RESISTANCE AND/OR UNUSUAL NOISE WHEN TURNING
STEERING WHEEL LEFT OR RIGHT**

Bulletin No.: 06-002/25

Last Issued : 11/13/2025

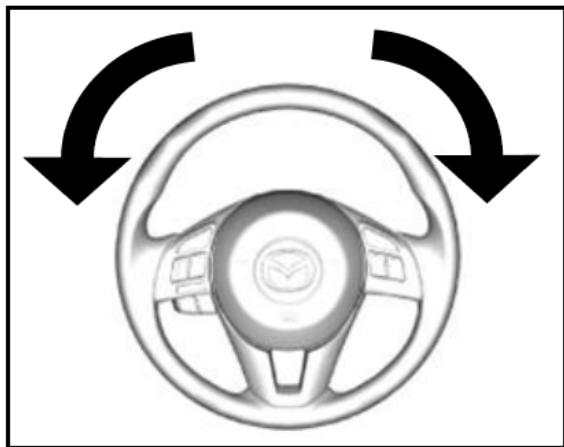
This concern may be caused by insufficient lubrication between the worm wheel gear and worm shaft. To eliminate this concern, **the amount of grease between the worm wheel gear and worm shaft was increased and the housing end cover shape was modified.**

Customers having this concern should have their vehicle repaired using the following repair procedure.
