# Technical Service Bulletin

<b>Subject:</b>  FUEL-FILLER LID CANNOT BE LOCKED AFTER AUTO-LOCK TIME HAS EXPIRED	<b>Bulletin No.:</b> 09-042/25
	<b>Last Issued :</b> 11/19/2025

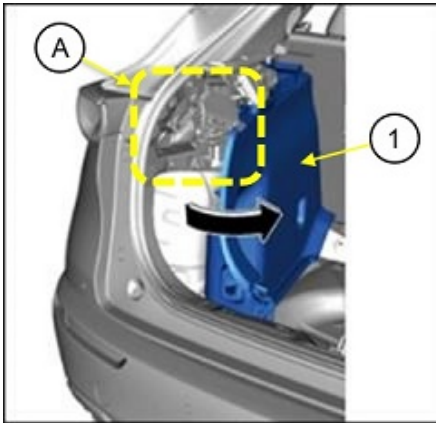
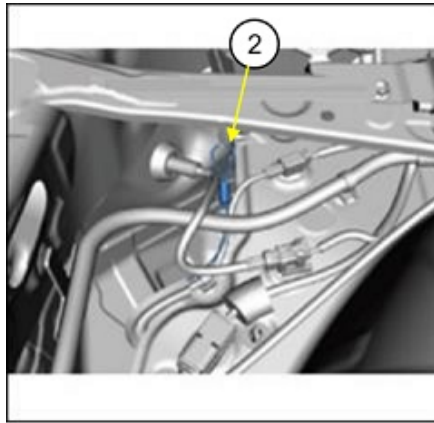
(1) Trunk side trim

Detail A: (2) Fuel-filler lid opener cable

1. Verify the customer concern by locking the doors and pressing the fuel-filler lid after 2 minutes to see if it opens.
  - If the fuel-filler lid can be opened, adjust the fuel-filler lid opener cable position using the Adjustment Procedure of Fuel-Filler Lid Opener Cable below.

2. After adjustment of the cable, wait for 2 minutes after locking the doors, then press the fuel-filler lid again to verify that

the lid does not open.

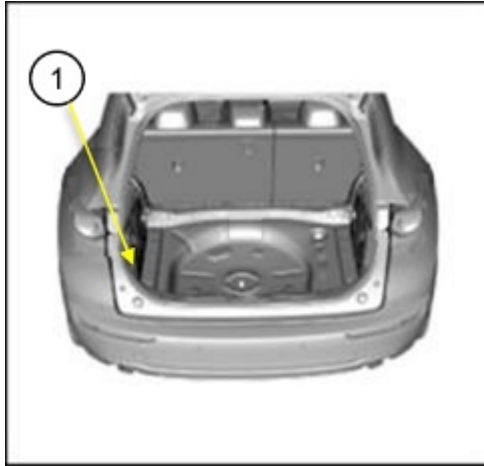
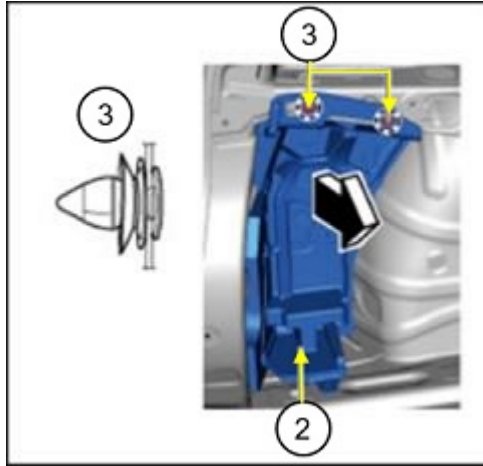
(1) Location of Trunk side insulator

(2) Trunk side insulator  
(3) Clip (2pcs.)

3. Remove the trunk side insulator.

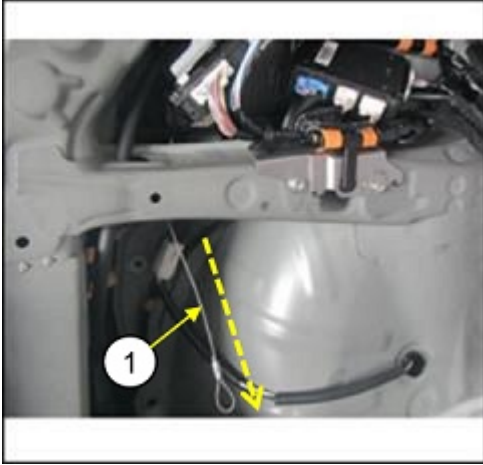
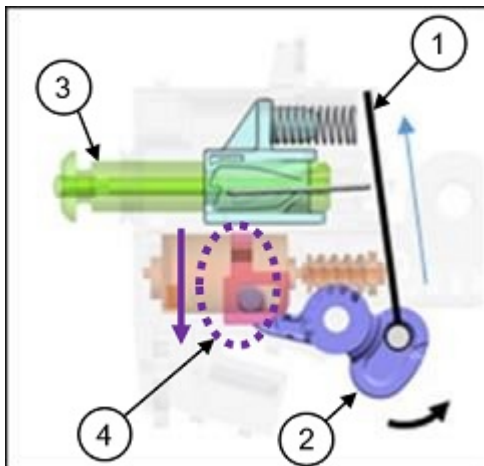
Inside of Fuel-Filler Lid Lock Actuator

**TIP:** By pulling the cable (1), the lock connected to the opener lever (2) leaves the cam hole and the actuator rod (3) is unlocked.

- (1) Opener cable
- (2) Opener lever
- (3) Actuator rod
- (4) Lock

5. Pull the fuel-filler lid opener cable (1) slowly to the end (manual release procedure). **NOTE:** DO NOT pull the cable with too much force, otherwise it could be damaged.

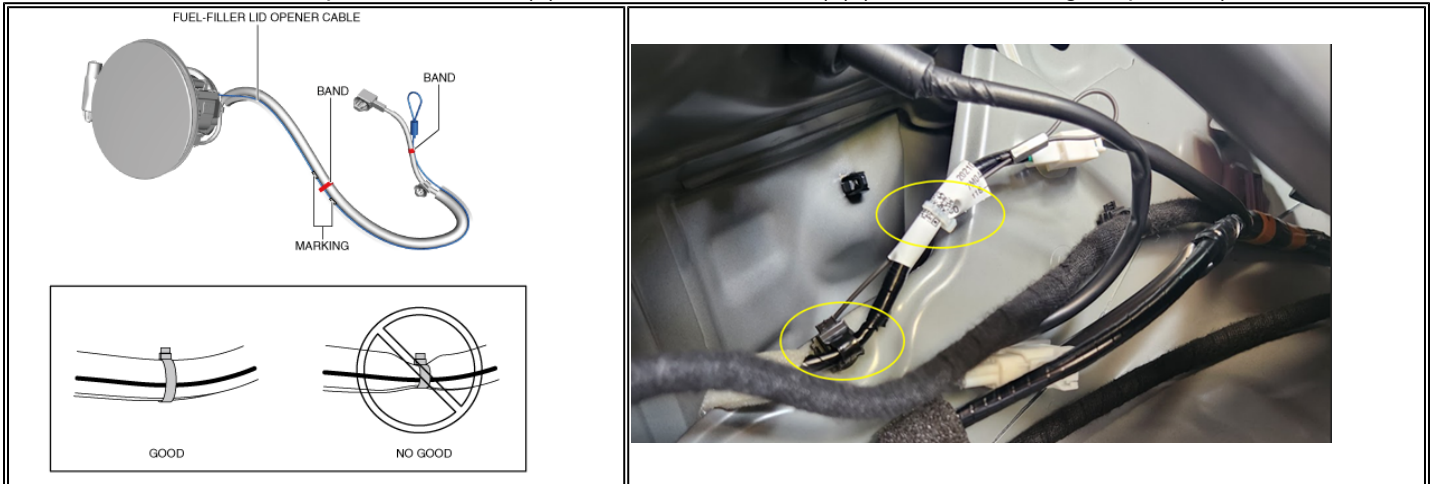
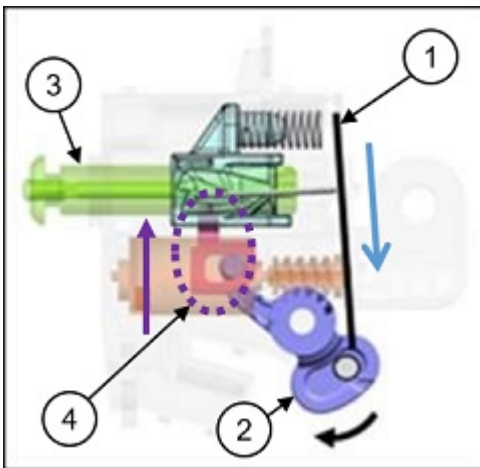
Inside of Fuel-Filler Lid Lock Actuator

**NOTE:** The fuel lid opener cable should allow the lever to be in the "lock allowed" position and should not be putting any tension on the lever to put it into the "emergency unlock" position.

**TIP:** By pushing the opener cable (1), the lock connected to the opener lever (2) inserts into the cam hole and the actuator rod (3) is locked.

- (1) Opener cable
- (2) Opener lever
- (3) Actuator rod
- (4) Lock

6. Secure the fuel-filler lid opener cable end (1) with another tie band (2) (return it to it's original position).
