RSB-56-25-002-1: Corrosion Below Door Handles

Document Type	Technical Service Bulletin
Date	November 19, 2025
Affected Region(s)	USA, Canada
Affected Model(s)	R1T, R1S
Model Year(s)	2022-2024
Approximate Build Dates	August 2021-April 2024

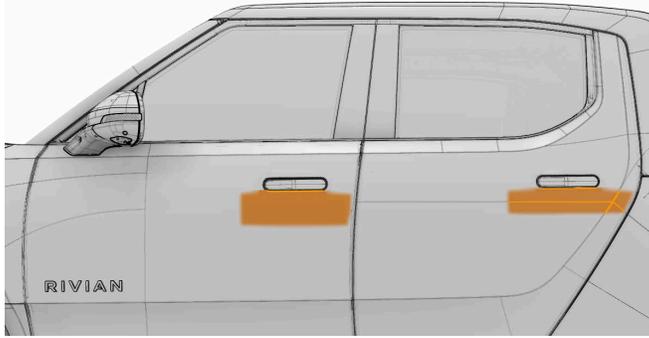
Rivian is launching a technical service bulletin for some model year 2022-2024 R1T and R1S vehicles that might have bubbles in the painted surfaces below the exterior door handles. On these vehicles, adhesive that secures an inner door reinforcement could allow contaminants to corrode the inner surface of the door over time, affecting the visual appearance of the door surface. Upon customer complaint, Rivian will repair and refinish the affected door(s).

1. On both sides of the vehicle: Check the highlighted area(s) for damage.

2.
 - If there are 1 or more bubbles in the paint in any of the highlighted areas: The component must be repaired by a Rivian Certified Collision Center. The Rivian Certified Collision Center will follow the steps in the [Procedure](#) section.
 - If there is no corrosion, or there is corrosion in another area of the vehicle: This bulletin is not applicable. Discontinue this procedure.
