Model(s)	Year(s)	VIN Range	Vehicle Specific Equipment
Q5, Q5 Sportback, SQ5, and SQ5 Sportback (GU)	2025	000000 – 070301	Not Applicable
Q6 e-tron, Q6 Sportback e-tron, SQ6 e-tron, and SQ6 Sportback e-tron (GU)	2025	000001 – 018606	PR# 7AA

One of the doors cannot be opened intermittently from the outside. It can always be opened from the inside. All other doors can be opened from the outside.

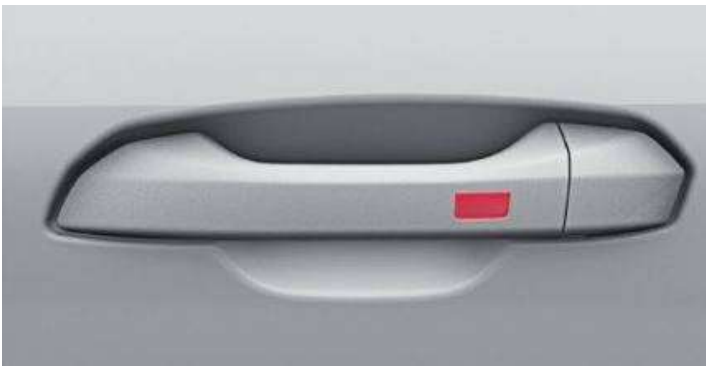
When opening the doors, care must be taken not to touch the sensor on the exterior door handle at the same time, e.g. with the thumb, otherwise the vehicle will lock again (Q6 e-tron example in figure 1).

Figure 1. The sensor is highlighted in red.

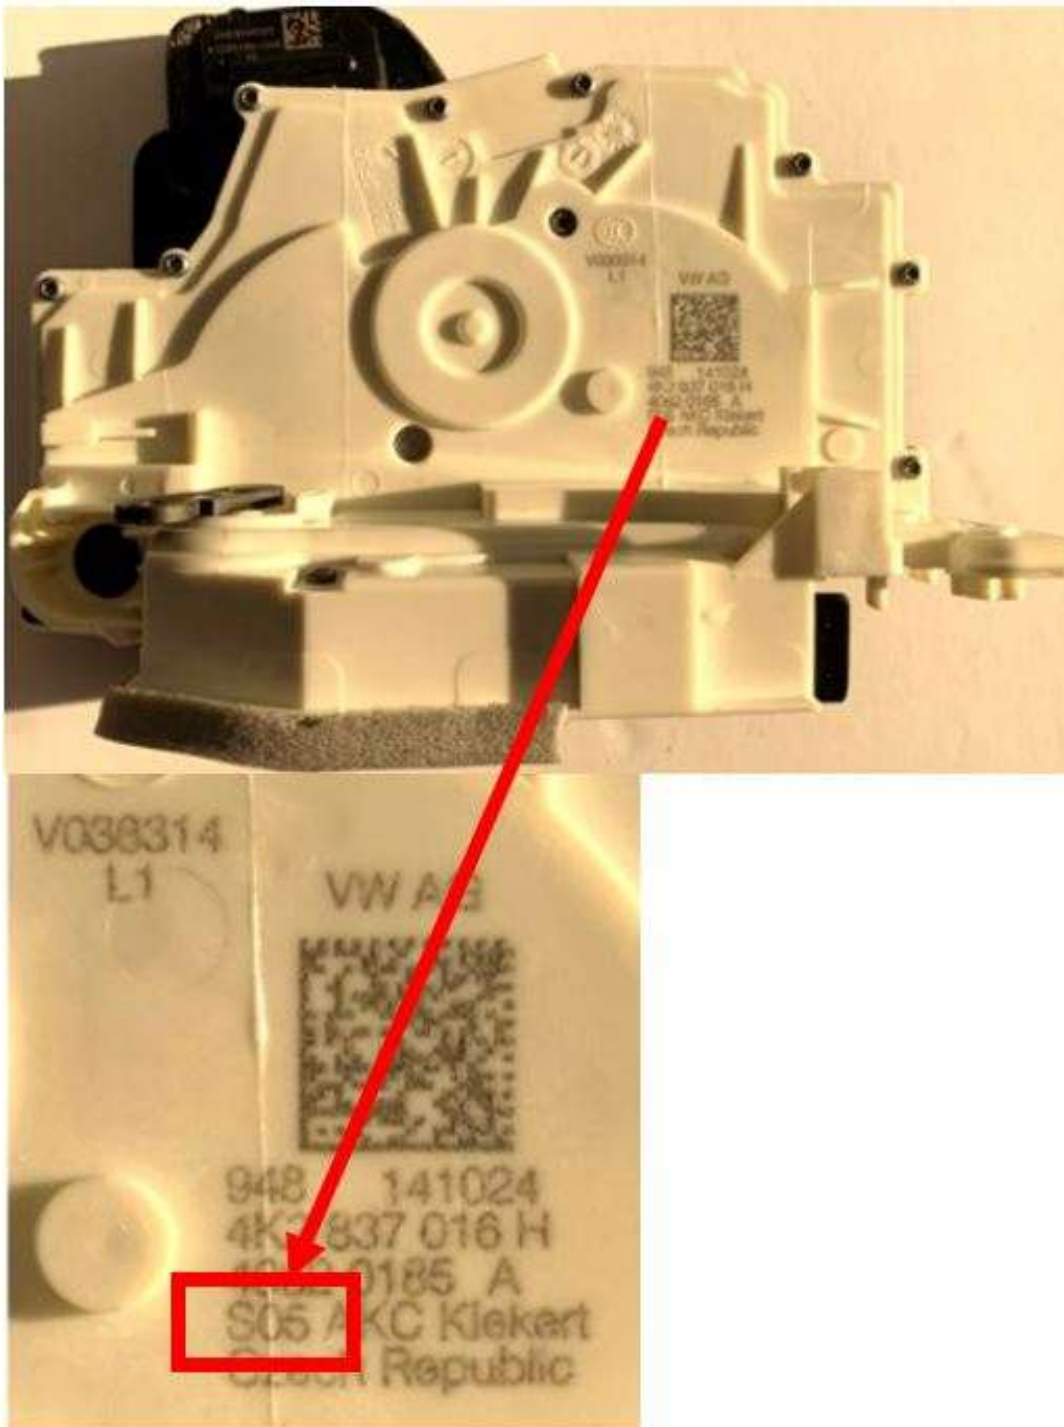
Please check the part version of the door lock installed on the faulty door (see figure 2) without removing the component.

Figure 2. The part version can be seen without removing the component.

If the part version is 08S or higher, please continue as described below under "Without event memory entry..."

If the part version is 07S or lower, please continue with the following measurement:

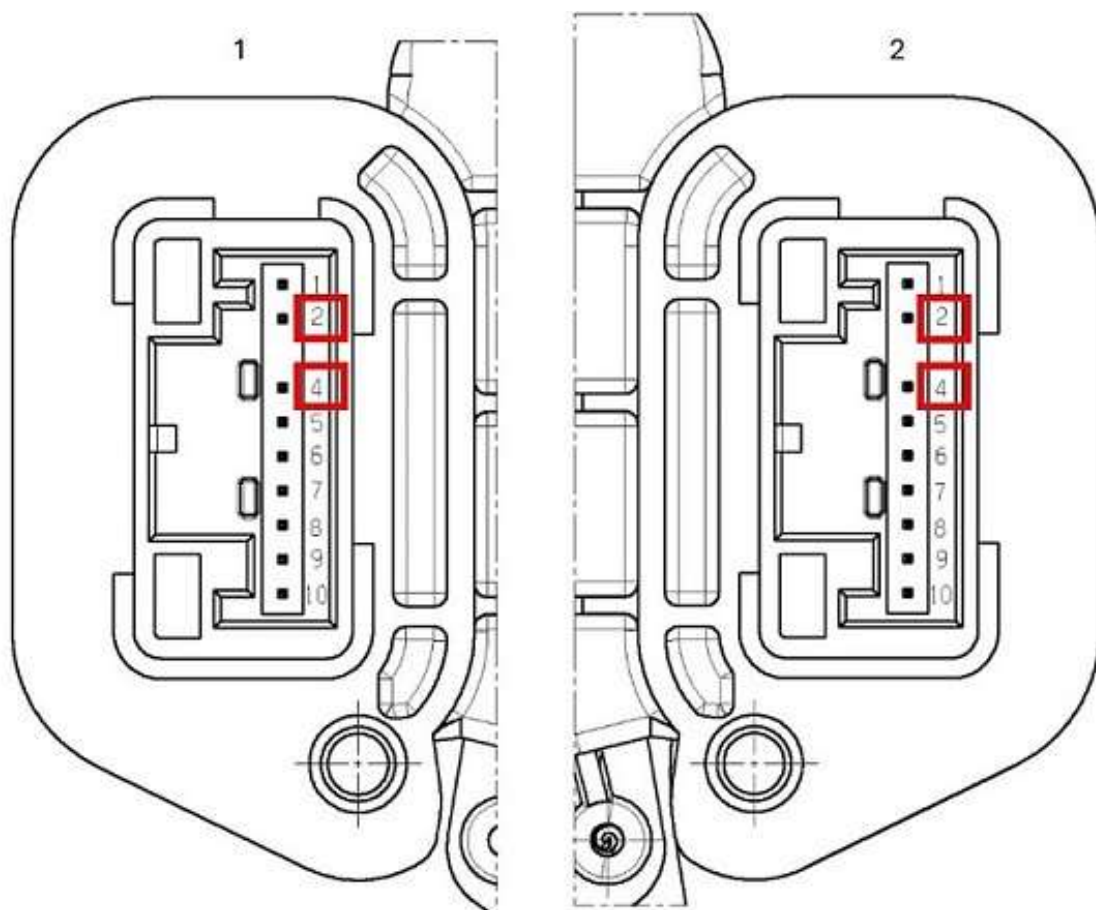
Please measure the resistance on the installed door lock between pin 2 and pin 4 (see Figure 3) using a multimeter. To do this, the lock must be in temporary crash redundancy mode. This is initiated by removing the connector from the lock and firmly pulling the interior door handle twice.

Figure 3. Illustration of the connector for the right door lock (1), and the left door lock (2).

Temporary crash redundancy (TCR) (without operating door handles): **1000 ohms**

IDH + TCR (operating interior door handle only): **382 ohms**

EDH + TCR (operating exterior door handle only): **212 ohms**

IDH + EDH + TCR (operating interior and exterior door handles simultaneously): **158 ohms**

If the results deviate from the specified values, please replace the affected door lock.

If the results correspond to the expected values, please check the lock wiring according to Guided Fault Finding. If this is OK, please replace the door control unit of the faulty door.
