High Pitch Whistling Noise From Outer Rear View Mirror

Service Category Vehicle Exterior

Section Mirror (ext)

YEAR(S)	MODEL(S)	ADDITIONAL INFORMATION
2023 - 2025	Sequoia HV	
2022 - 2025	Tundra, Tundra HV

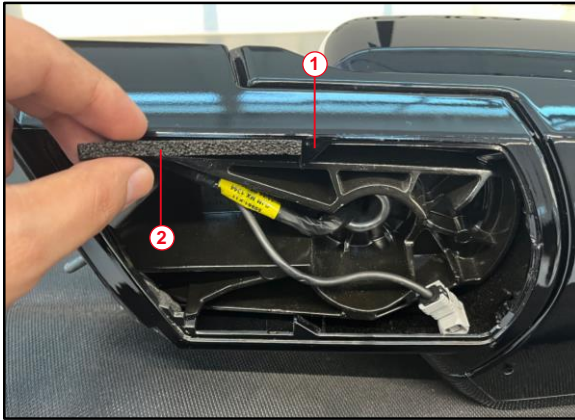
1	Triangle
2	EPT Foam Strip

7. Starting at the triangle, apply the EPT foam strip on the inside rib as shown in Figure 3. The EPT foam strip should be positioned as shown in Figure 4.

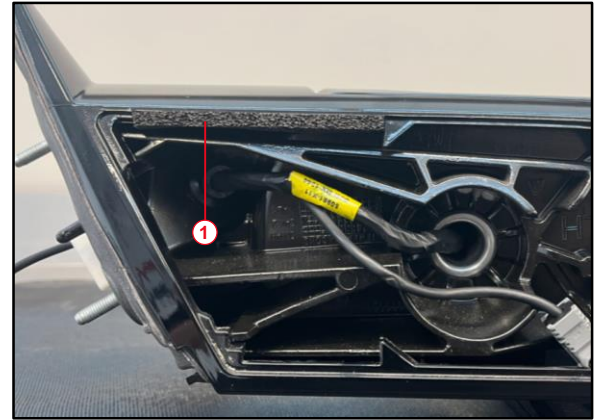
Figure 4.

1	EPT Foam Strip
----------	-----------------------
