## Y1A, Y1B, Y1C- High-Voltage (HV) Battery Measurements during HV Battery Repair

| Models | Model Year | Model Type | VIN Range | Vehicle-Specific Equipment |
|---|---|---|---|---|
| Taycan | As of 2020 up to 2024 | Y1A, Y1B, Y1C | All | N/A |

**Bulletin #: 2518**

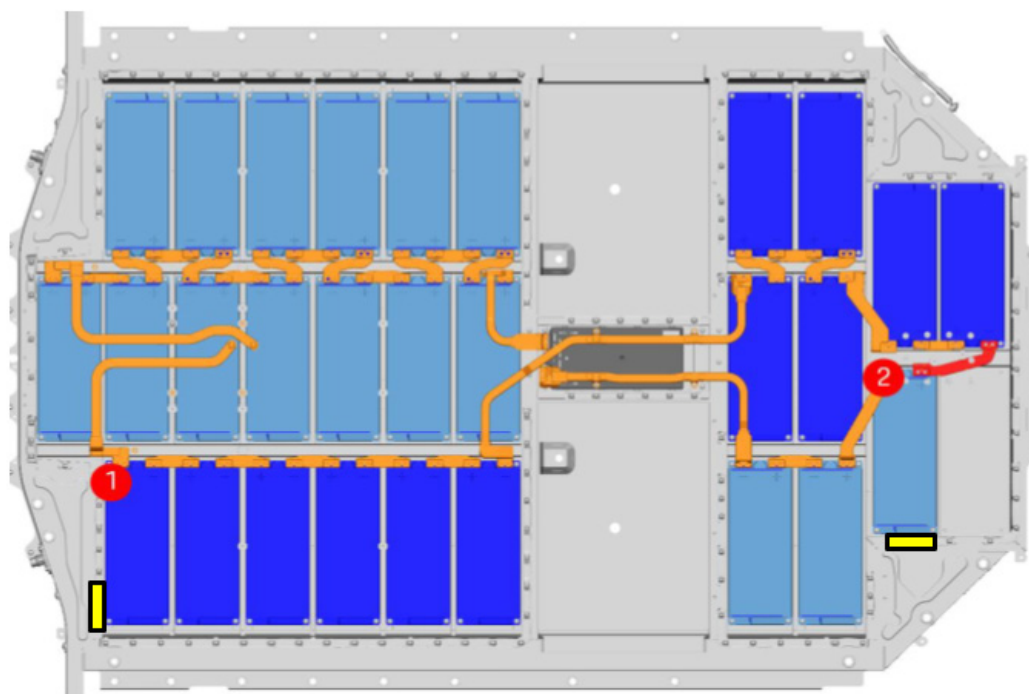
**Figure 1** - 28-module HV Battery measurement points

- Also perform IR tests at points 1 and 2 after a DST, with the negative probe also on the surface designated by the yellow boxes.
- If the DST at measurement point 1 fails, remove busbars and CMC connections from each module shaded in dark blue for further IR testing as described in the following *Updated IR Measurement Procedure* sections.

- If the DST at measurement point 2 fails, remove busbars and CMC connections from each module shaded in light blue module for further IR testing as described in the following *Updated IR Measurement Procedure* sections.

- EXAMPLE: Point 1 passes DST and point 2 fails.
  - Perform IR tests on each light blue module in the failing section (In this example, section 2). No additional work is required for the passing modules in section 1.

- Only two DSTs are to be performed on a 28-module battery pack during repair.
- During a DST, only personnel with a 40 Cal Arc Flash suit and approved PPE may be permitted within the cordoned HV safety zone around the battery pack.

- The busbar indicated in red must be removed prior to measurements at either point.
- Perform an IR test at points 1 and 2 before the DST at those points.

- Perform a DST only at points 1 and 2 shown below for each repair scope.
- The yellow boxes in Figure 1 designate the sections of laser clean surface (silver stripe) to contact using the negative probe to ground the dielectric strength tester. This method ensures consistency in testing.

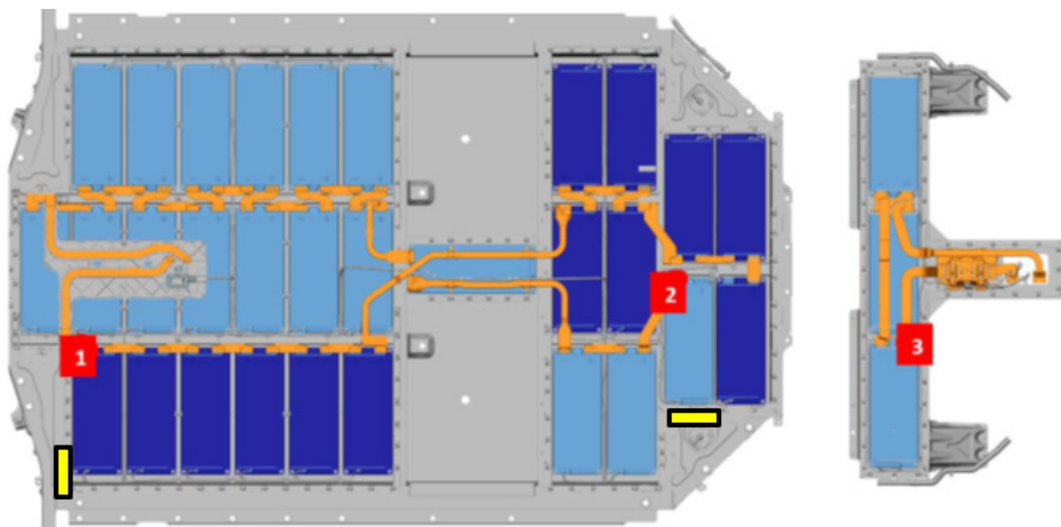
**Figure 2** - 33-module HV Battery measurement points

- Perform IR tests at points 1, 2, and 3 after a DST, with the negative probe also on the surface designated by the yellow boxes.
- If the DST at measurement point 1 fails, remove busbars and CMC connections from each module shaded in dark blue for further IR testing as described in the following *Updated IR Measurement Procedure* sections.

- If the DST at measurement point 2 fails, remove busbars and CMC connections from each module shaded in light blue for further IR testing as described in the following *Updated IR Measurement Procedure* sections.

- If the DST at measurement point 3 fails, remove busbars and CMC connections from each module in the upper "T" section for further IR testing as described in the following *Updated IR Measurement Procedure* sections.

- EXAMPLE: It is possible for battery to have point 1 pass, point 2 pass, and point 3 fail the DST. It would then only be required to perform further IR tests on each module in the upper "T" section. No additional work would be required for the passing lower sections.

- Only a total of three or four dielectric strength tests are to be performed on the 33-module battery pack during repair, depending on scope.
- If removed, the upper "T" Section should be placed aside on a VAS 6762/44 Insulating mat during testing.

- Perform an IR test at points 1, 2 and 3 before the DST at those points.
- Perform a DST only at points 1, 2, and 3 for any repair scope involving the lower-level modules.

- Repair scopes in only the upper "T" section require an initial DST (in addition to the points in figure 2) at the mid-pack fuse as shown in step 3.9.3 of Safety test after assembly work on the high-voltage battery with 33 modules in WM 270803A5. If the DST fails, proceed with removing the lower lid and perform DSTs at points 1, 2, and 3 as identified below.

- The yellow boxes in Figure 2 designate the section of laser clean surface (silver stripe) to contact using the negative probe to ground the dielectric strength tester. This method ensures consistency in testing.

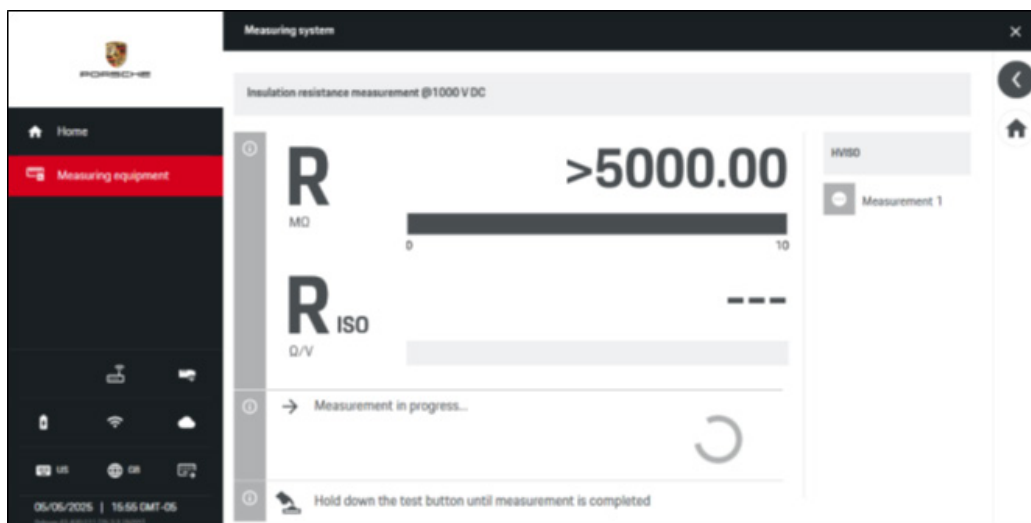
**Figure 5** - Insulation resistance measurement in PIWIS Tester

- Shown below is an example of passing test result of >5000 MΩ. This is the reading when IR measures above the 500 MOhm measuring threshold.
- If the first IR test on either module terminal fails, but the second one passes, the module is okay and should not be replaced.
- If any second terminal IR test shows a number below 500 MΩ, this is considered a failure.
- Report any failures to PCNA Technical Support via PRMS for approval of any additional module replacements during repair. Specify the total count of replaced modules for a repair vs replacement decision.
- Document these results in the "Module insulation Resistance Template" Excel file attachment and attach to the PRMS Ticket and repair PCSS entry.
