992 Lightweight Rear Quarter Glass Panes Are Cracked

Vehicles Affected

Revision History

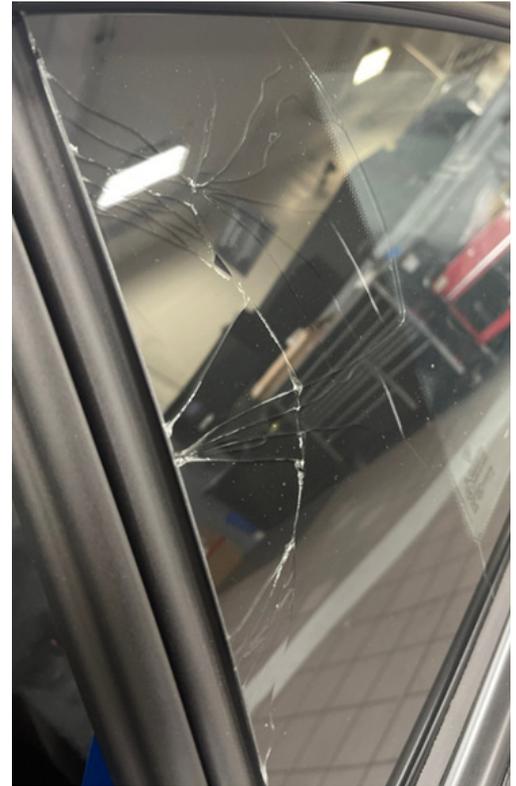
Figure 1

The customer and the workshop find cracks in the rear quarter glass (non-moveable side windowpane). These cracks are typically found toward the front of the vehicle, closer to the door. (Please see figure 1.)

Please replace the affected glass pane(s) as instructed in *WM 647519 – Removing and installing side window (Coupe)*.
